**Milestone Phase I Report**  
**Roll's Landing Condominium Association, Inc.**

Report Date: 7/12/2024

Inspection Date: 3/21/2024

Per your request, a team from Stone Inspections Group, LLC (SIG) conducted a Phase I Milestone Inspection of the referenced property on the following buildings:

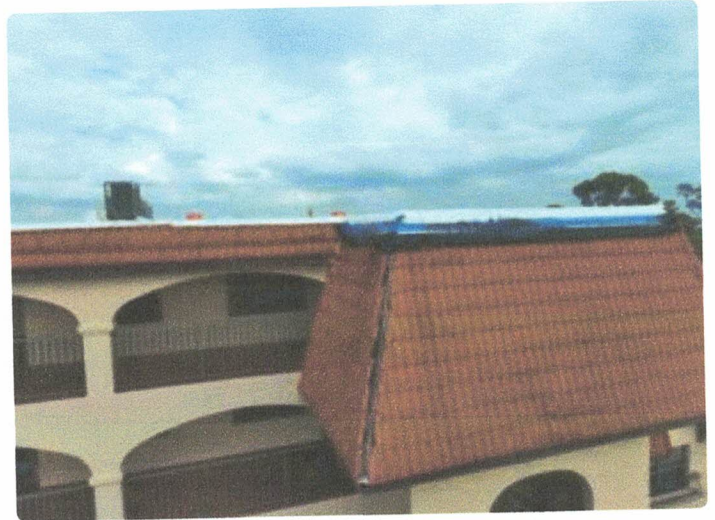
Broken barrel tiles

Broken barrel tiles and remedial solutions observed. Recommend replacing all broken tiles and repairing temporary remediation failure. Flat roofs were tarped up for remediation in plans to replace. Recommend replacing the flat roof. Soffit missing throughout property. Recommend replacing all missing soffit

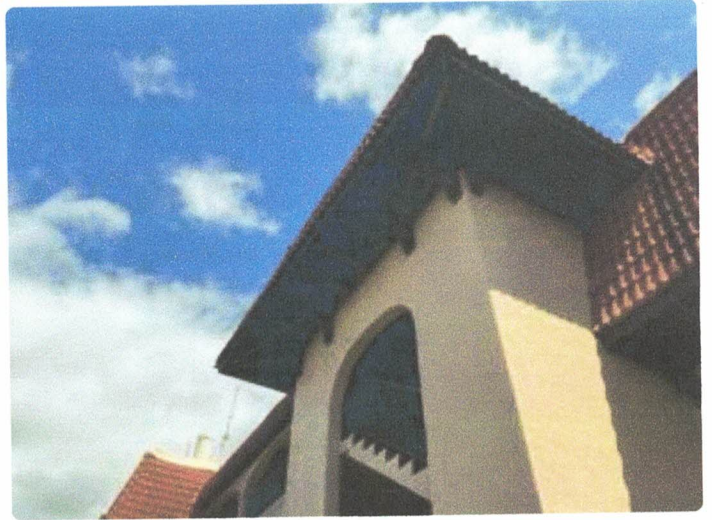
Missing soffit

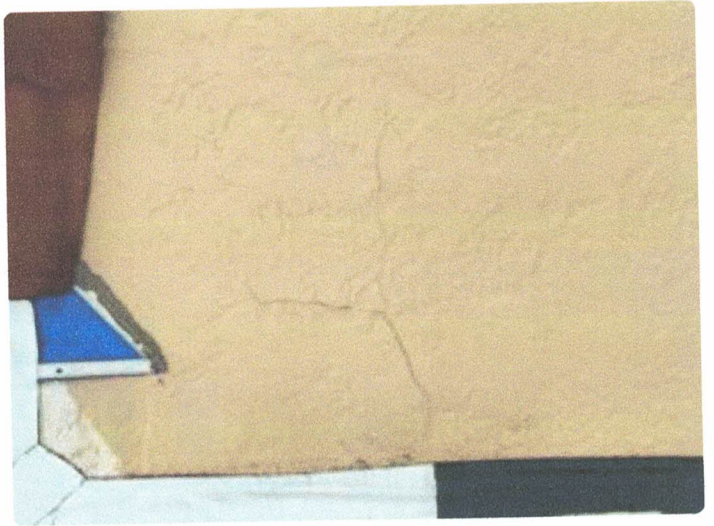
Crack in exterior wall on roof

| Maintenance | Crack in stucco on roof of building 9. Recommend routing and patching with mortar. |

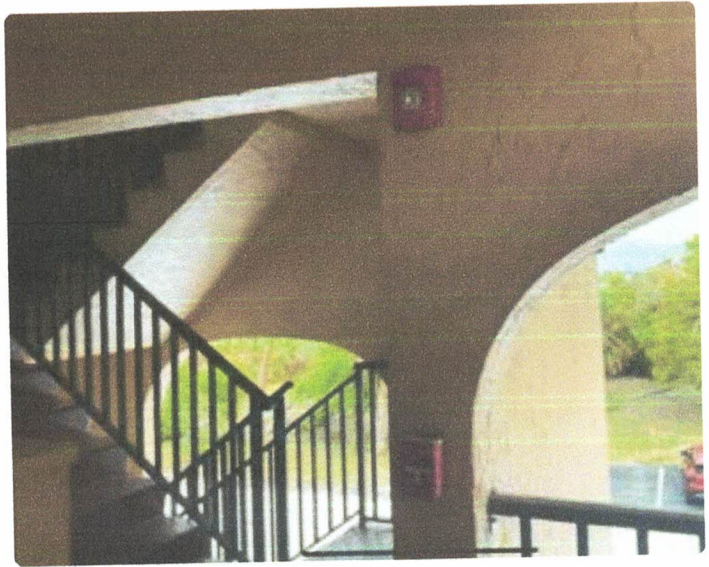
Typical stairwell

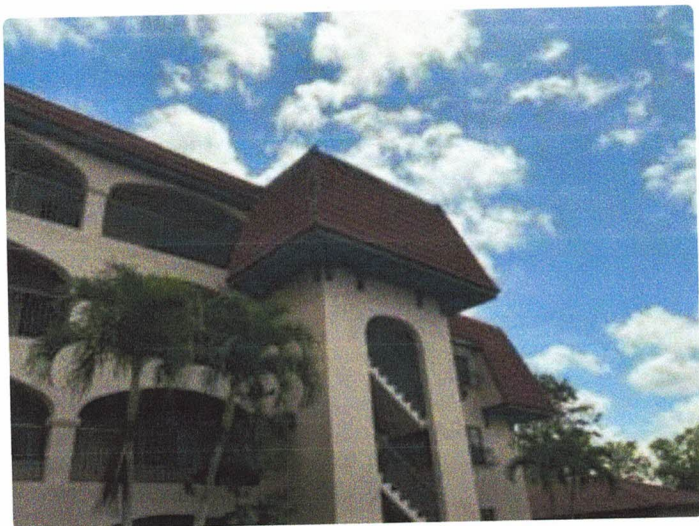
Broken barrel tiles

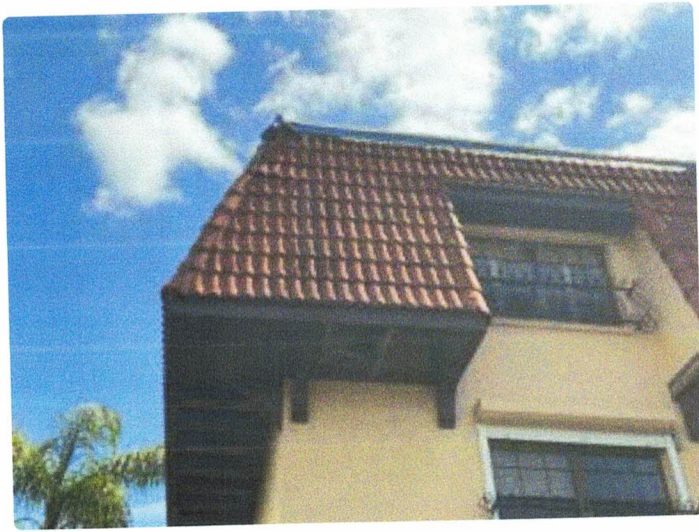
Broken barrel tiles

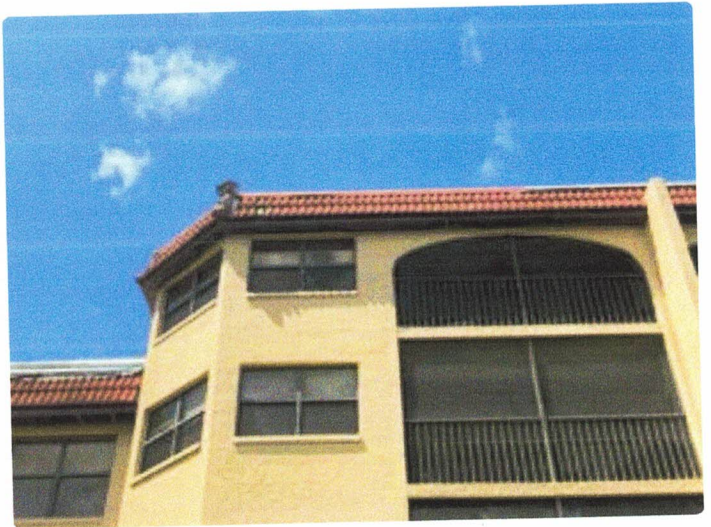
Broken barrel tiles

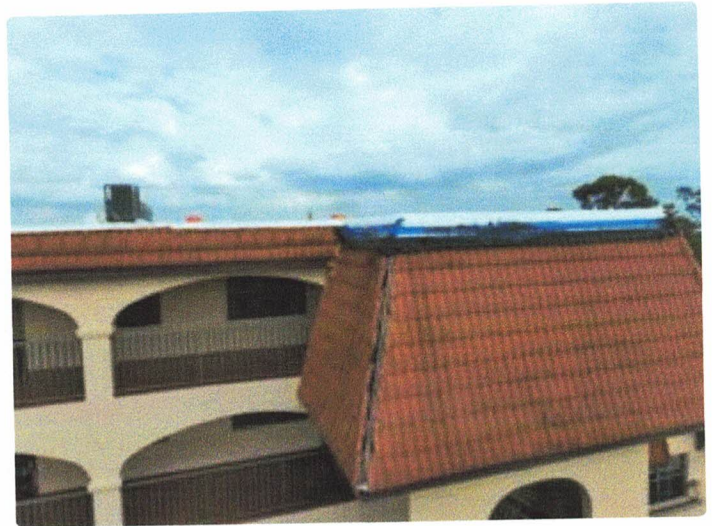
Broken barrel tiles

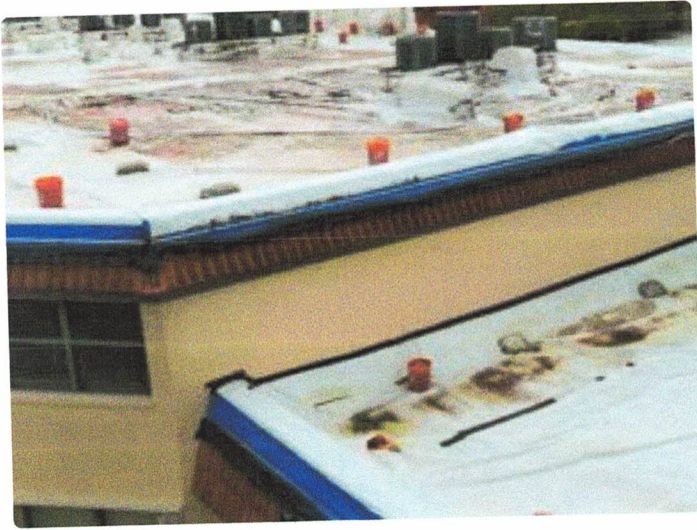
Broken barrel tile

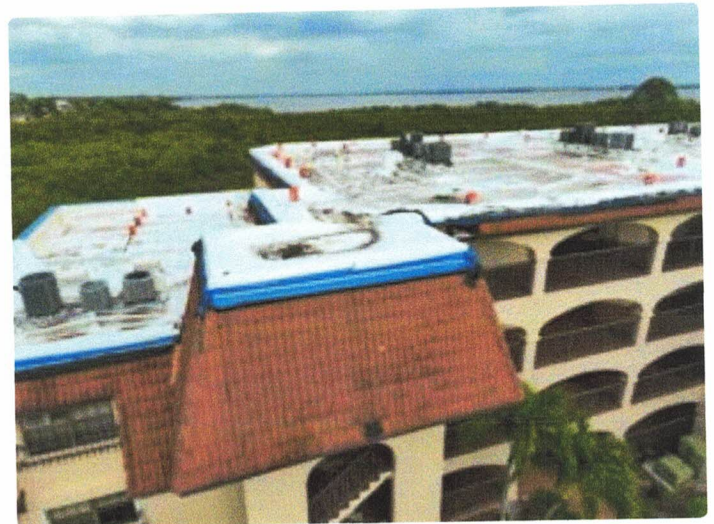
Broken barrel tiles

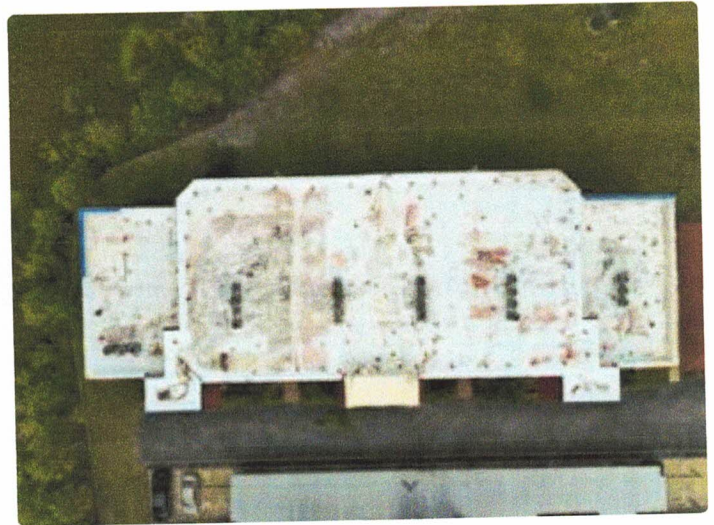
Temporary remediation on roof

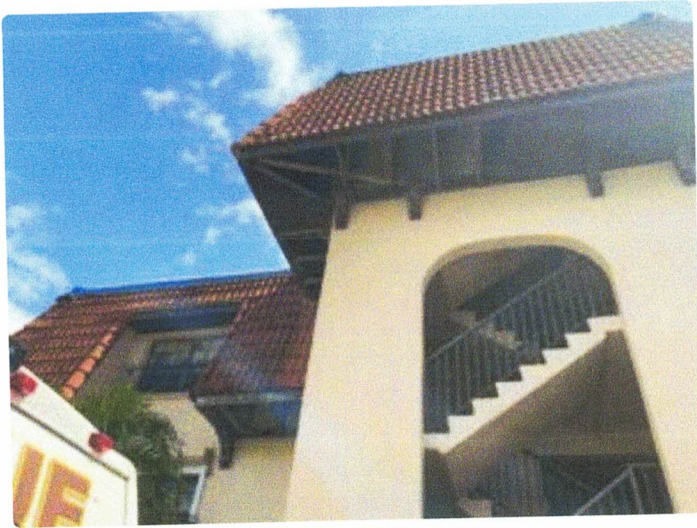
Missing soffit

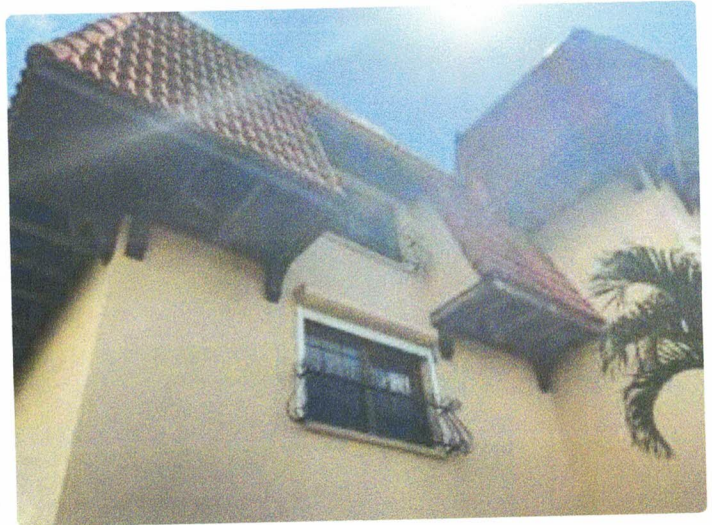
Missing soffit

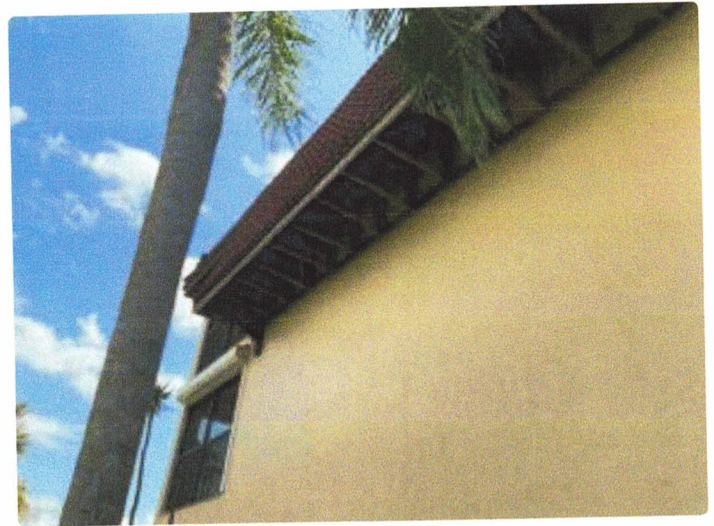
Missing soffit

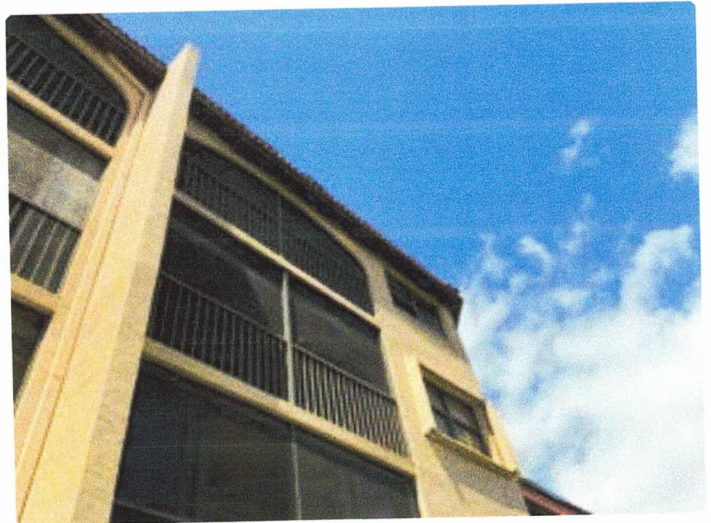
Missing soffit

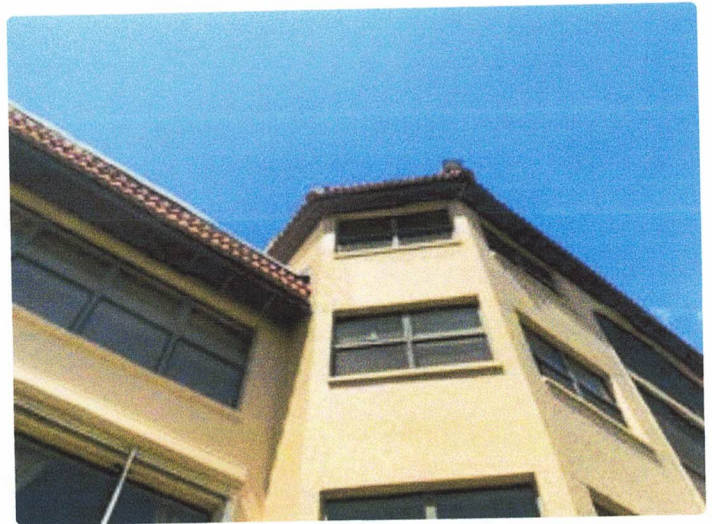
Missing soffit

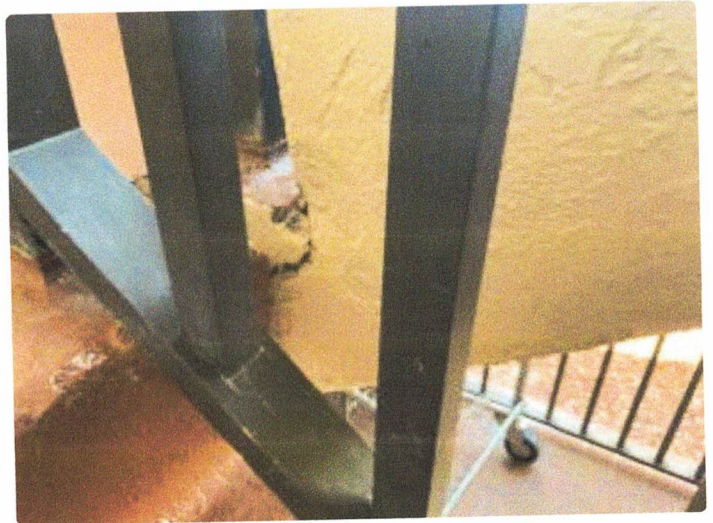
Spalling on inside of stairwell

Spalling was also observed at the insides of several landings. Recommend hiring a contractor to perform ultrasonic pulse velocity testing of all landings on and between floors on buildings 2, 6, 7, and 9. Testing will determine the extent of the spalling and will indicate if it can be patched with mortar or if parts of the landings need to be replaced.

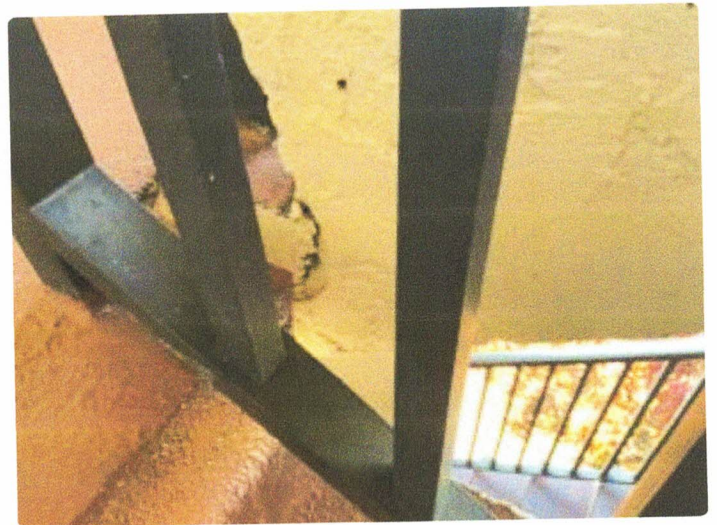
Spalling inside stairwell

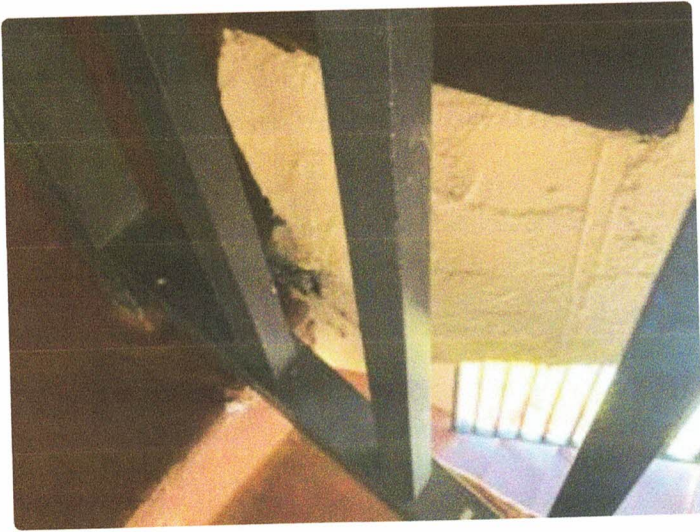
Spalling inside stairwell

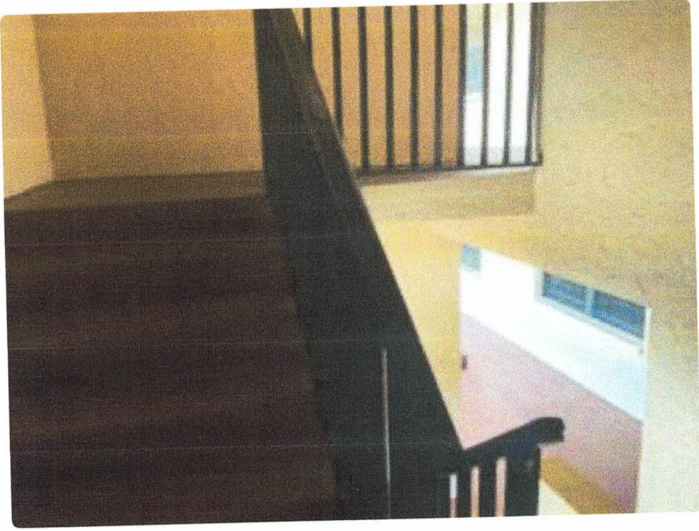
Loose railing cover

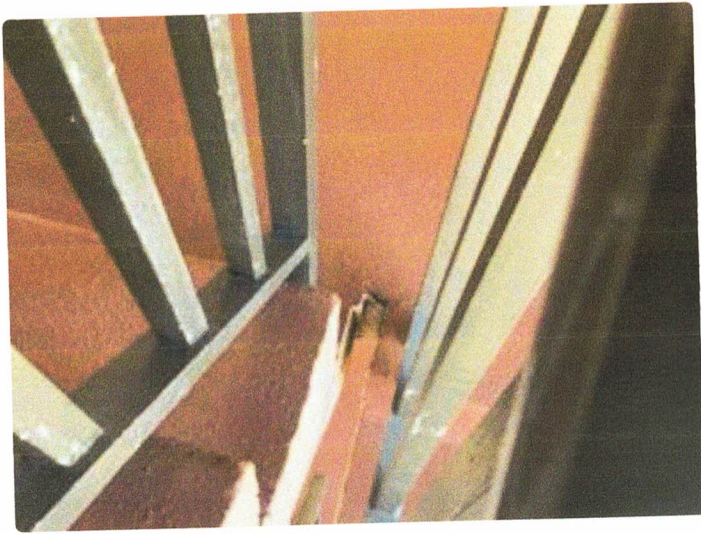
Spalling at landing on stairway

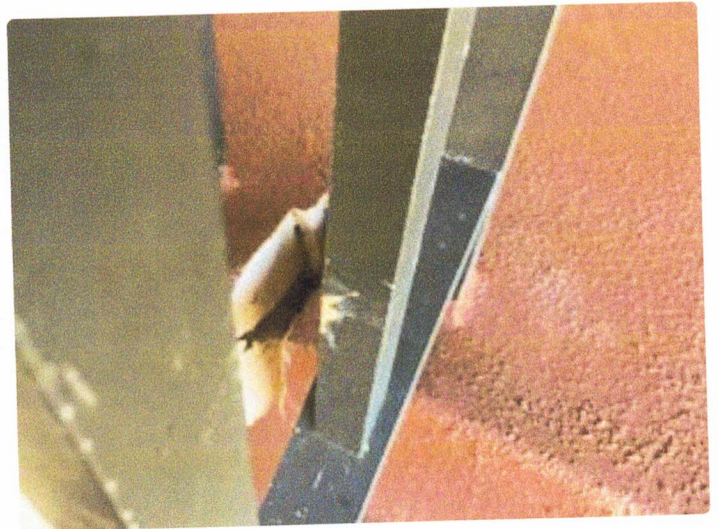
Spalling at landing on stairway

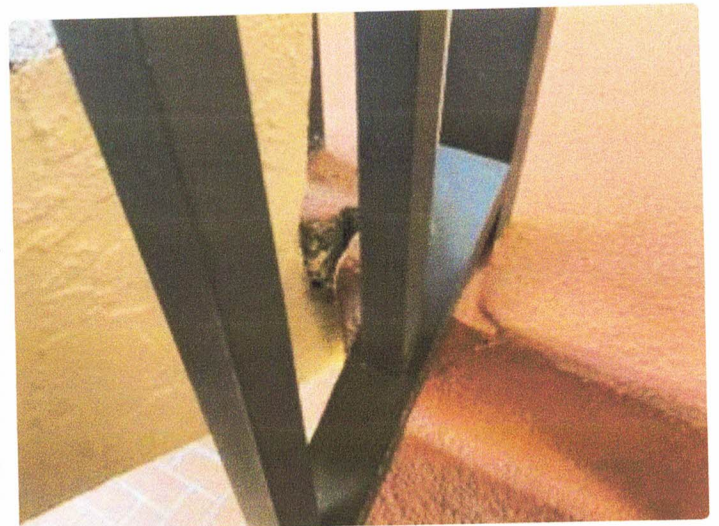
Spalling at landing on stairway

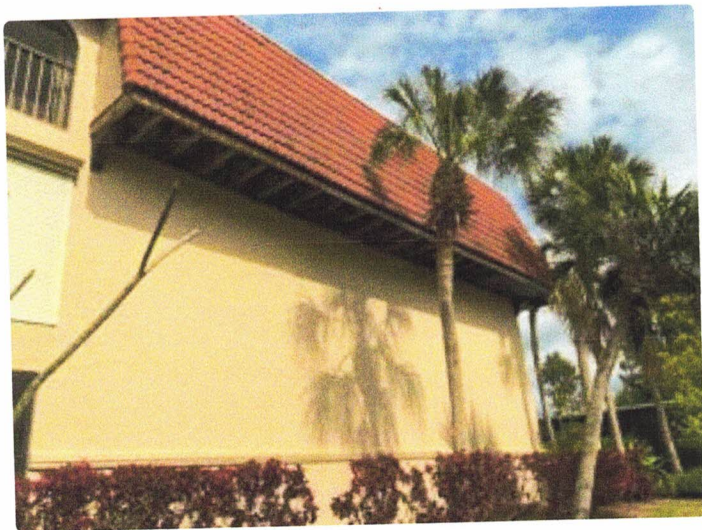
Missing soffit

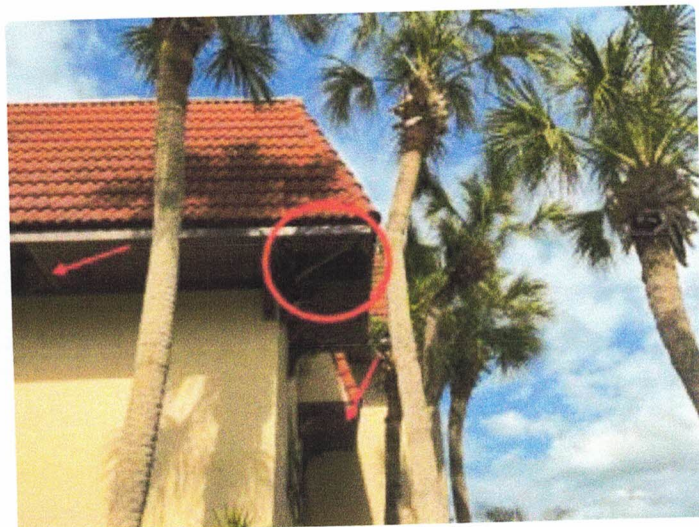
Missing soffit

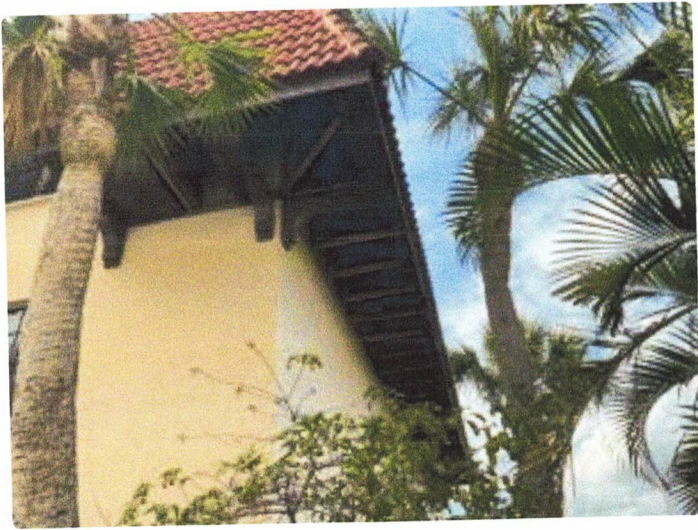
Missing soffit

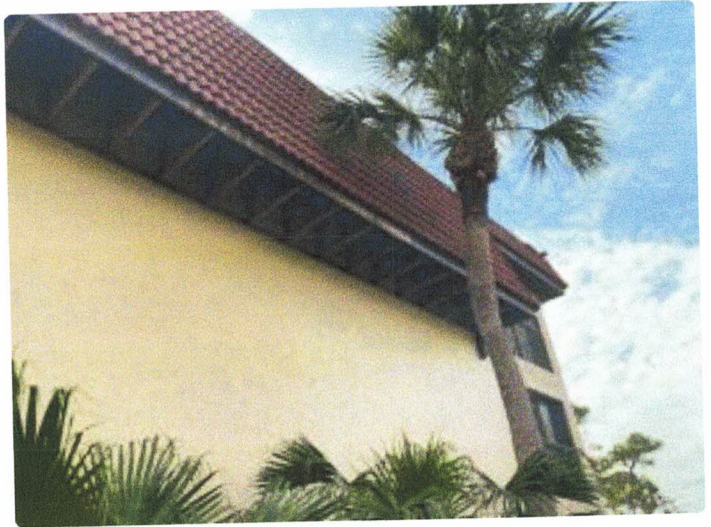
Missing soffit

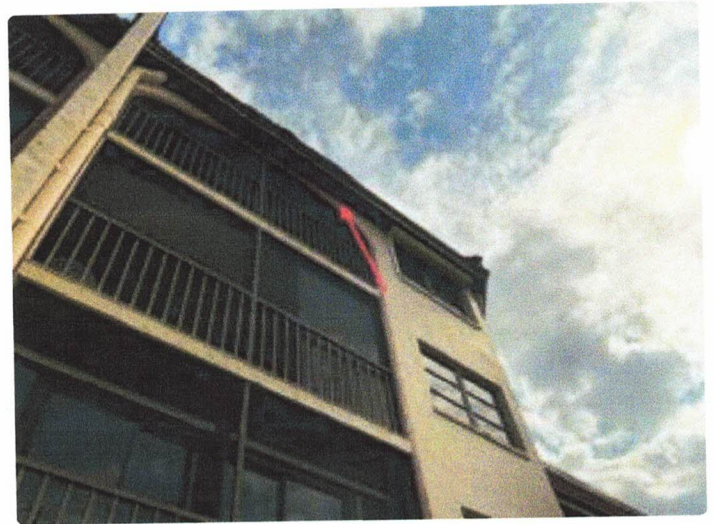
Missing soffit

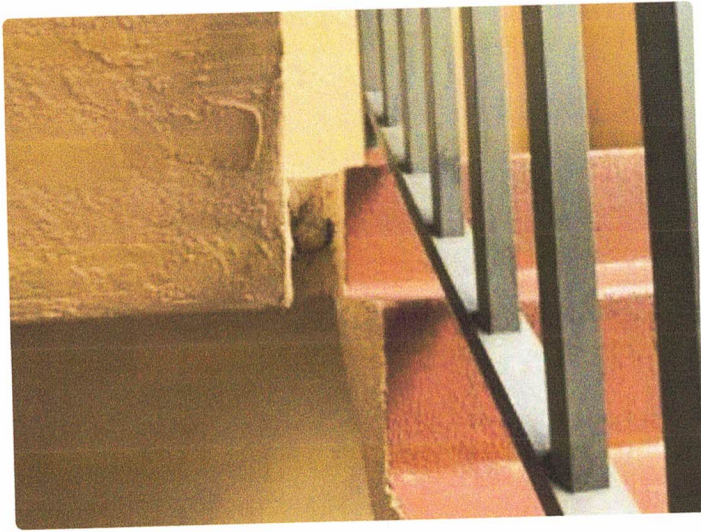
Spalling on left stairwell landing

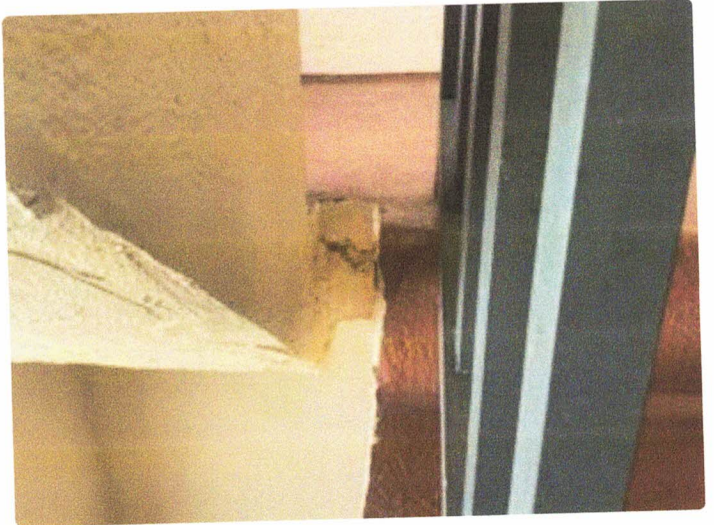
Spalling on left stairwell landing

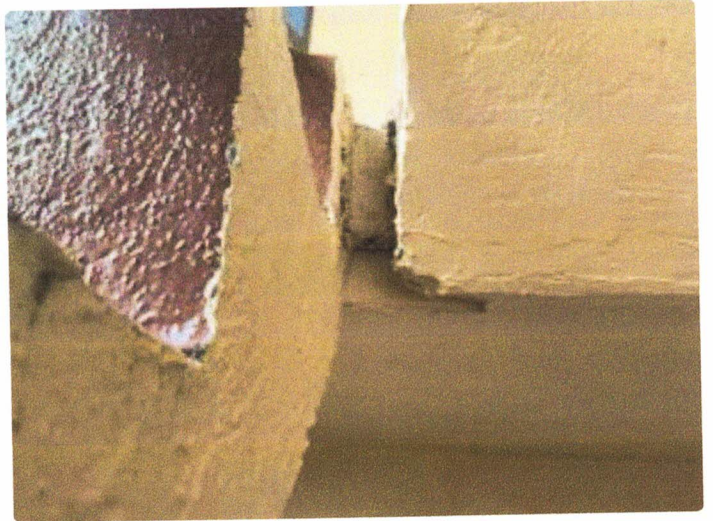
Spalling on right stairwell landing

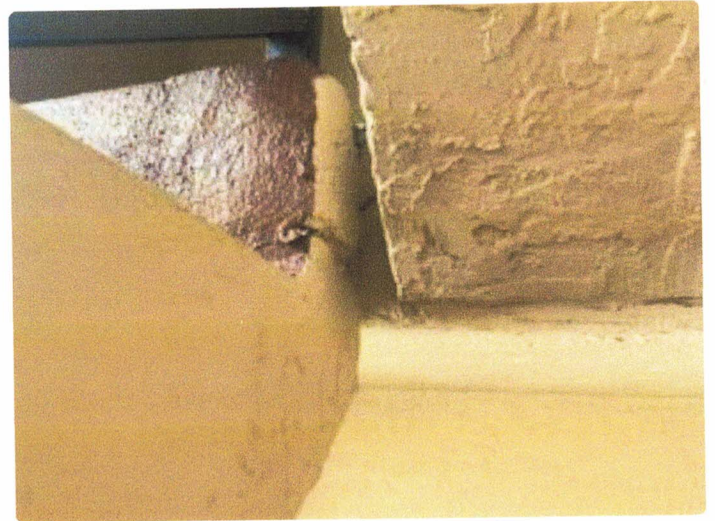
Spalling on right stairwell landing

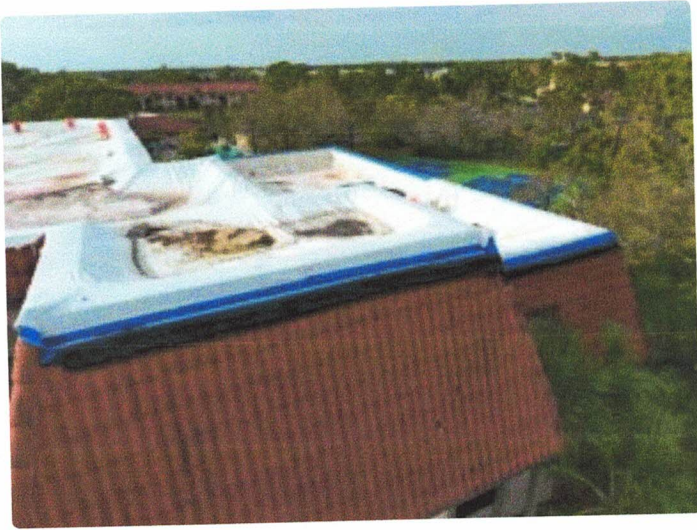
Broken barrel tiles

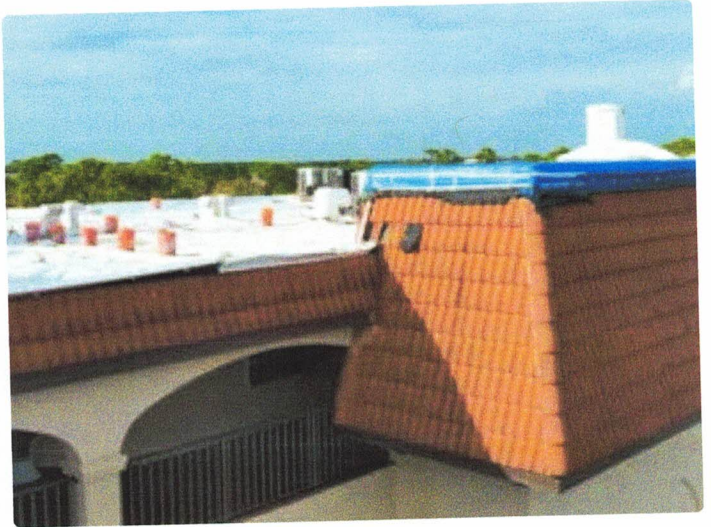
Broken barrel tiles

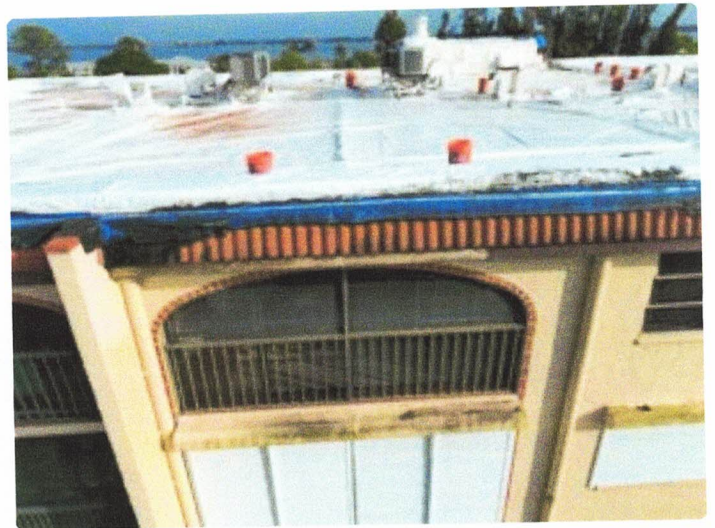
Broken barrel tiles

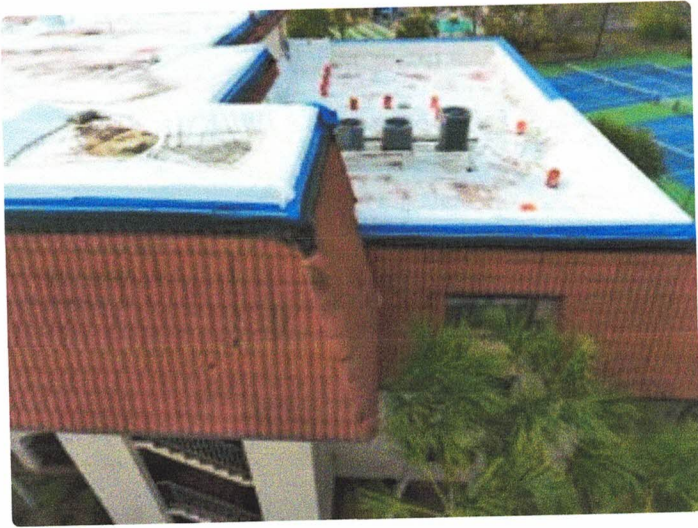
Broken barrel tiles

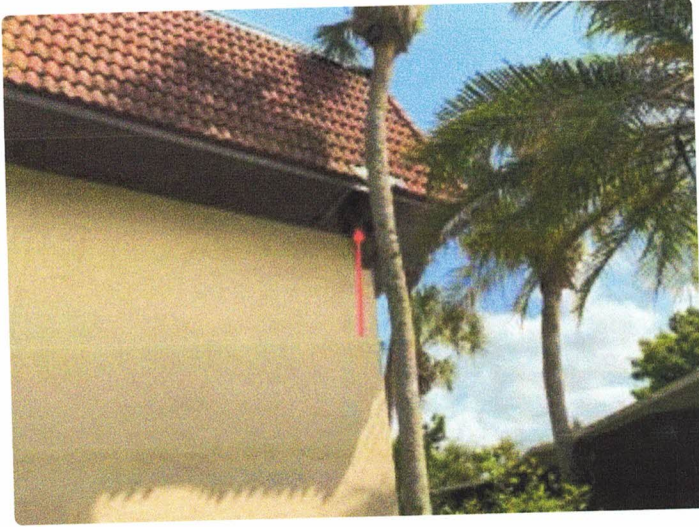
Missing soffit

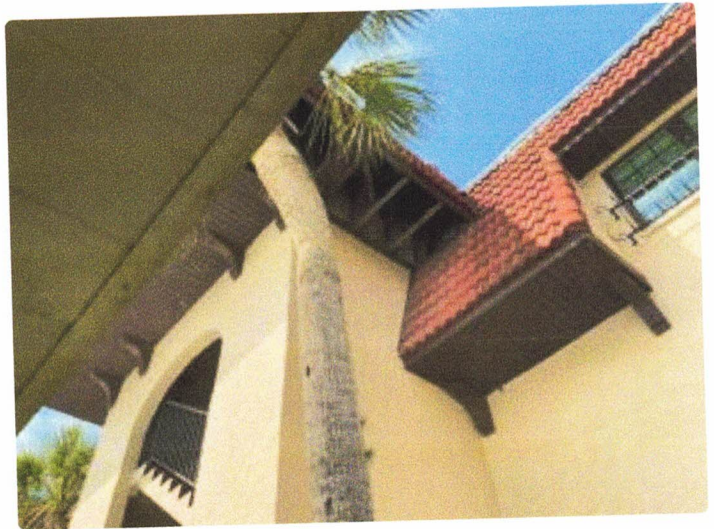
Missing soffit

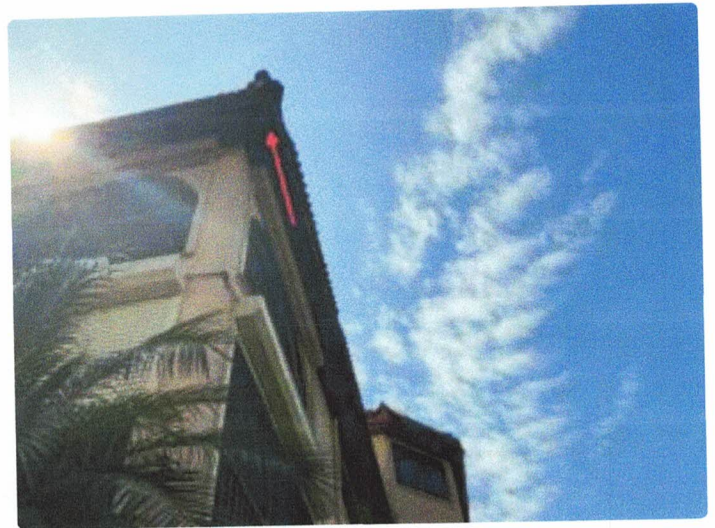
Missing soffit

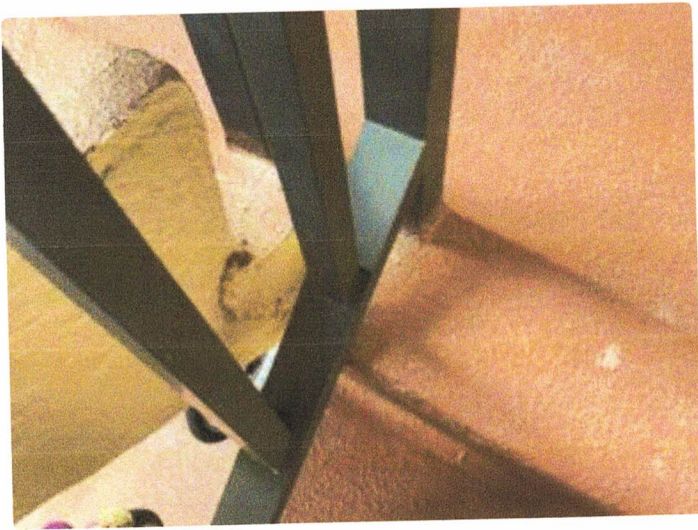
Spalling on left stairwell landing

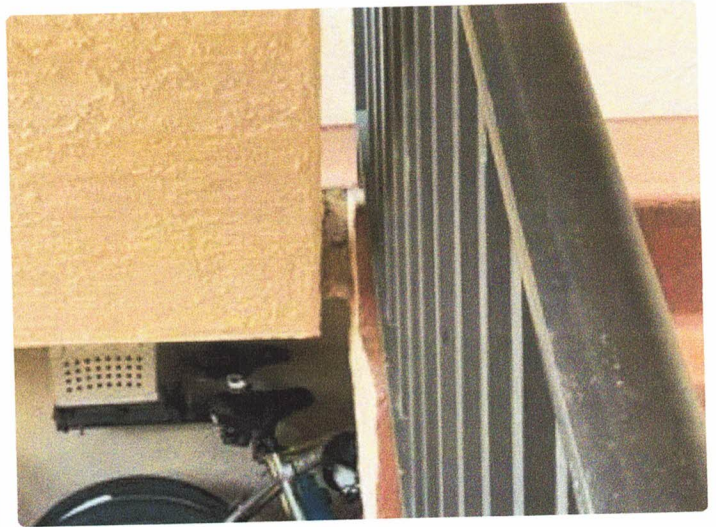
Spalling on left stairwell landing

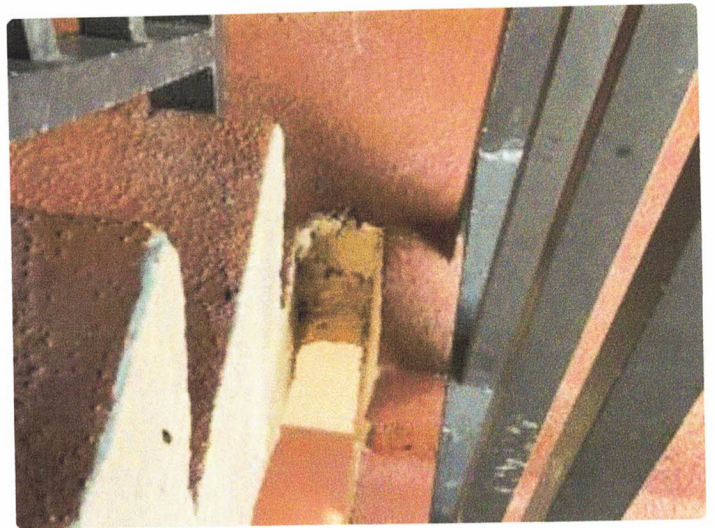
Spalling on left stairwell landing

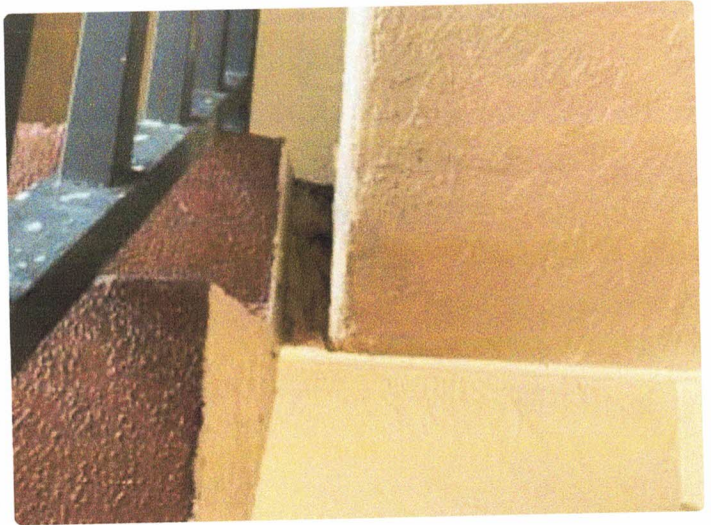
Spalling on right stairwell landing

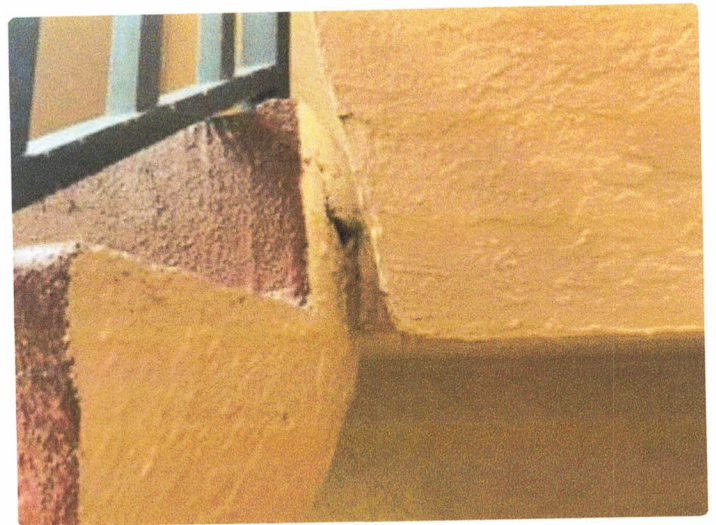
Spalling on right stairwell landing

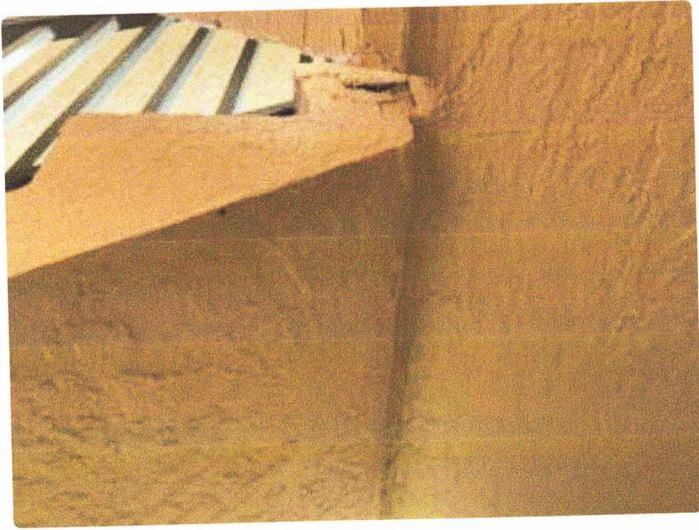
Spalling on right stairwell landing and cracking underneath

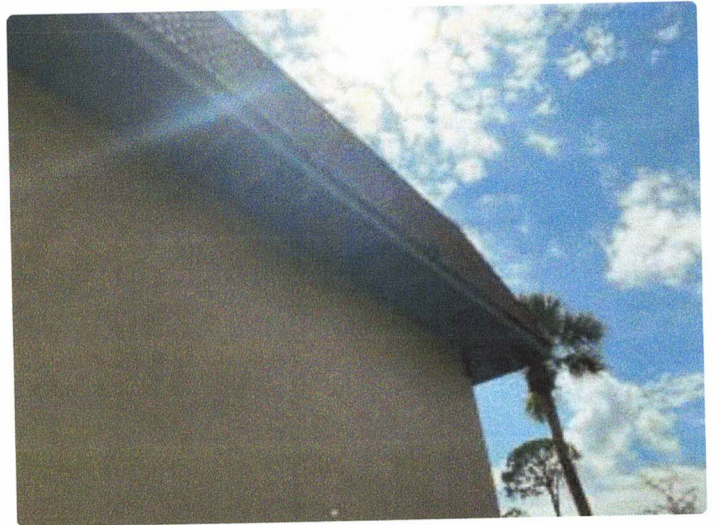
Missing soffit

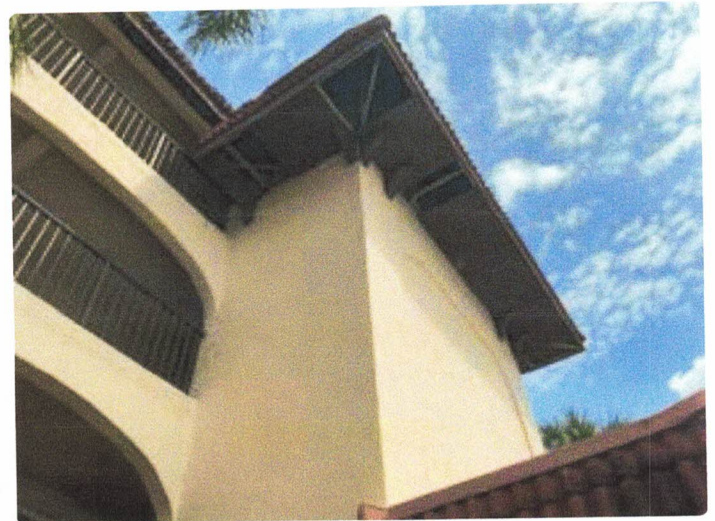
Missing soffit

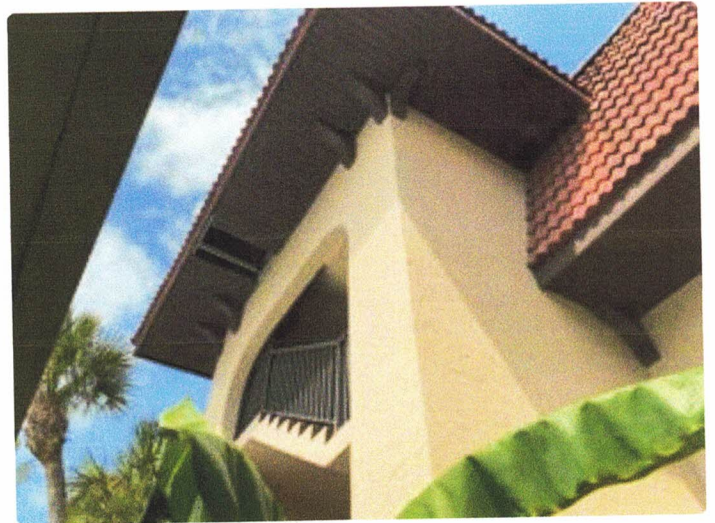
Missing soffit

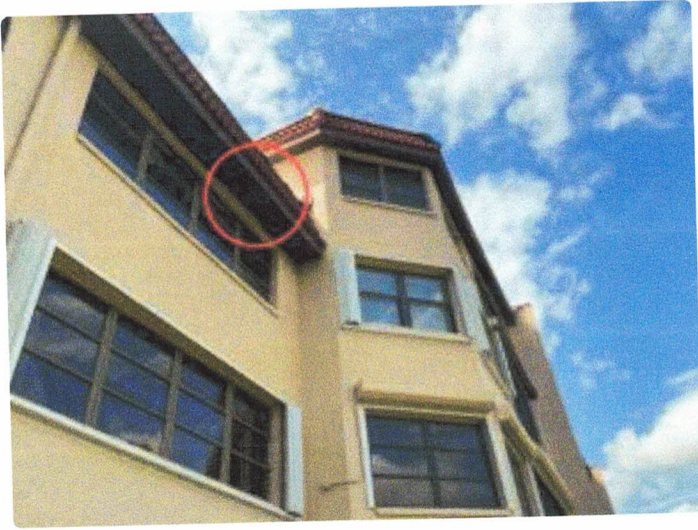
Missing soffit

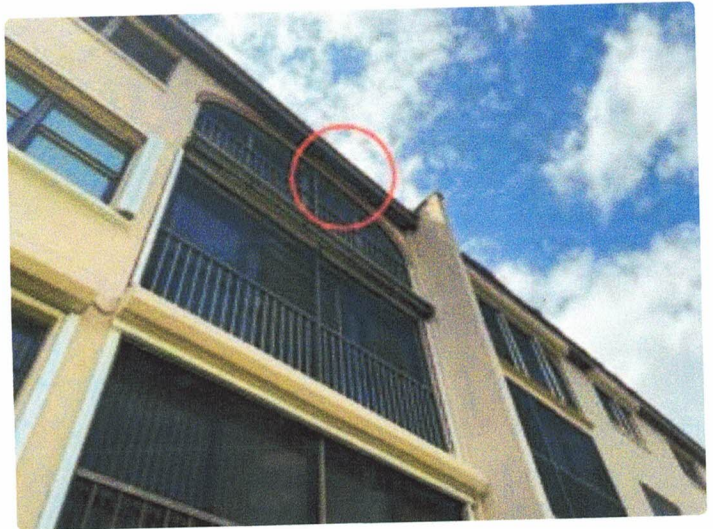
Missing soffit

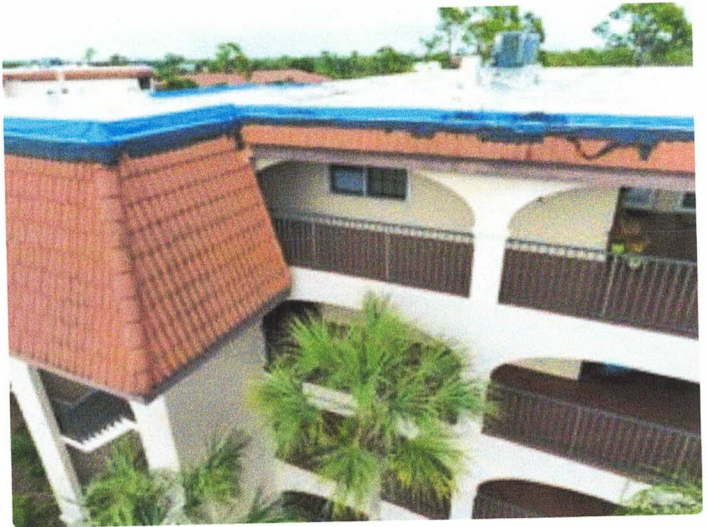
Temporary remediation failure

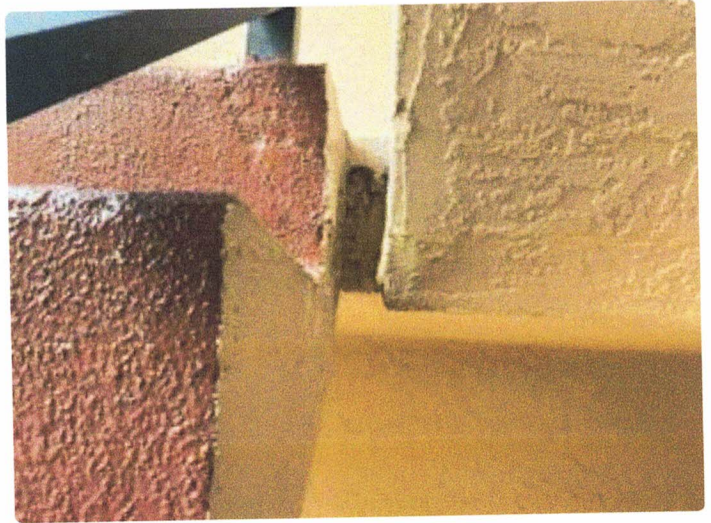
Spalling on right stairwell landing

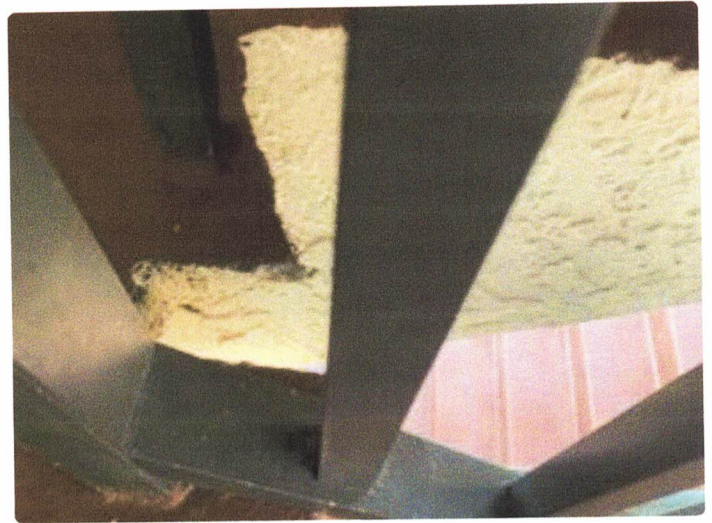
Spalling on right stairwell landing

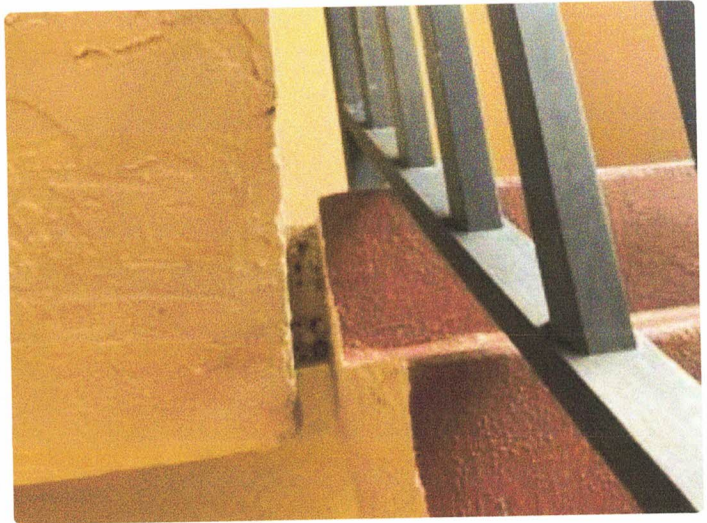
Spalling on left stairwell landing

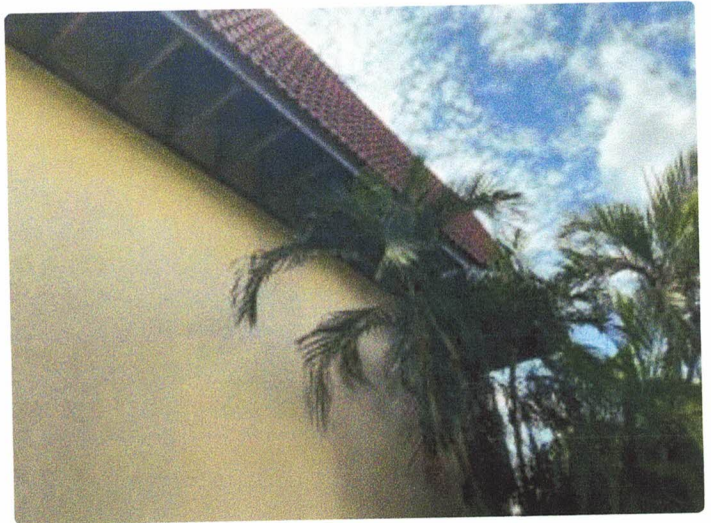
Missing soffit

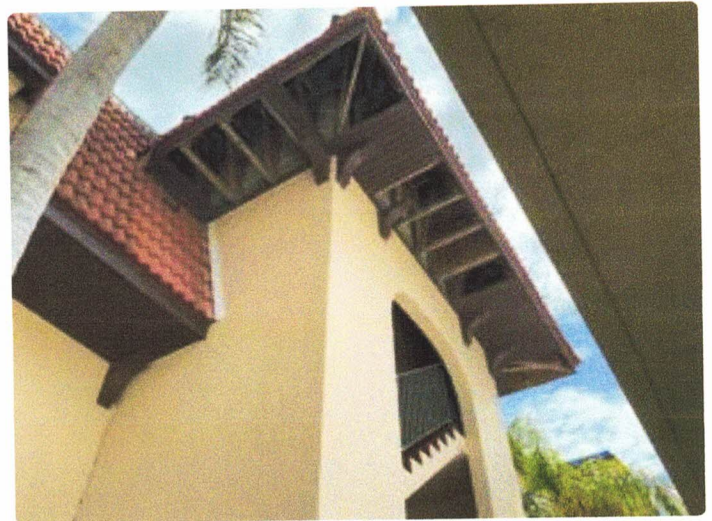
Missing soffit

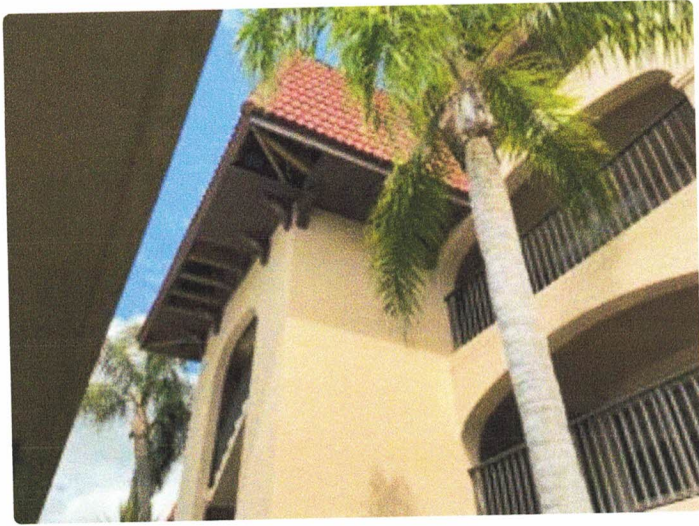
Missing soffit

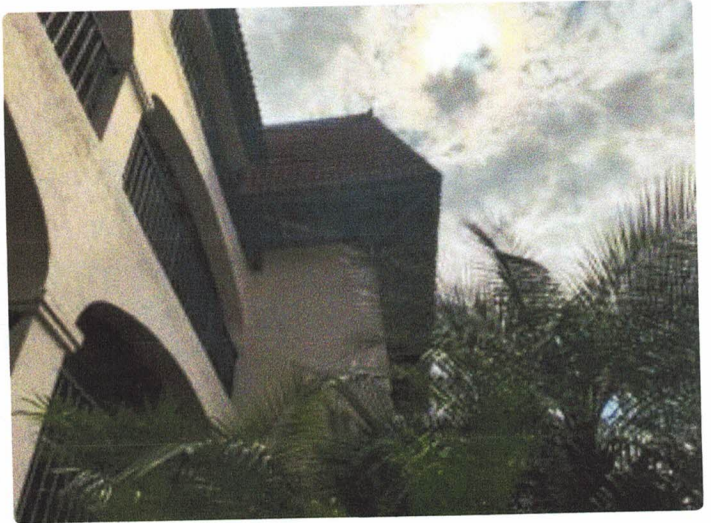
Missing soffit

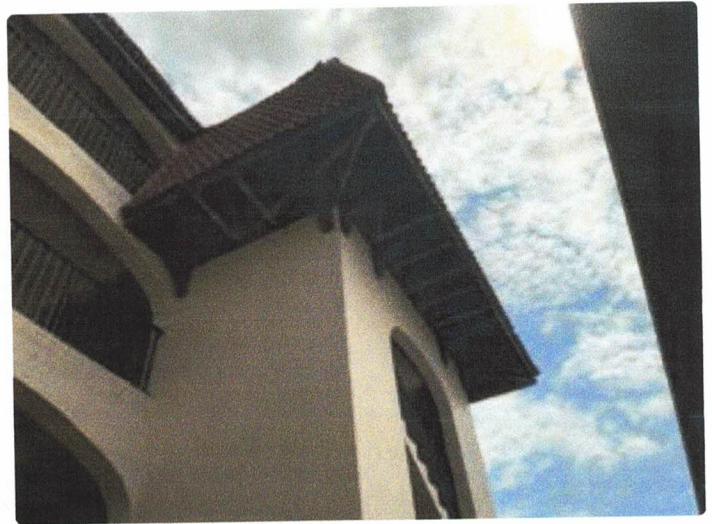
Missing soffit

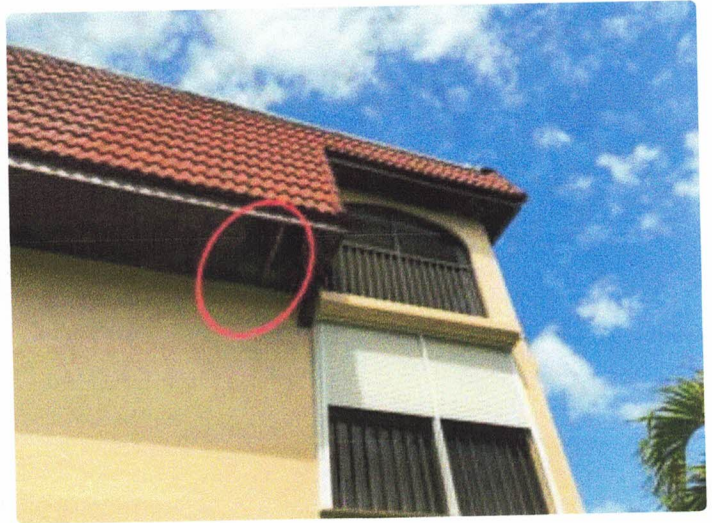
Missing soffit
