**Milestone Phase I Report**  
**Roll's Landing Condominium Association, Inc.**

Report Date: 7/12/2024

Inspection Date: 3/21/2024

Per your request, a team from Stone Inspections Group, LLC (SIG) conducted a Phase I Milestone Inspection of the referenced property on the following buildings:

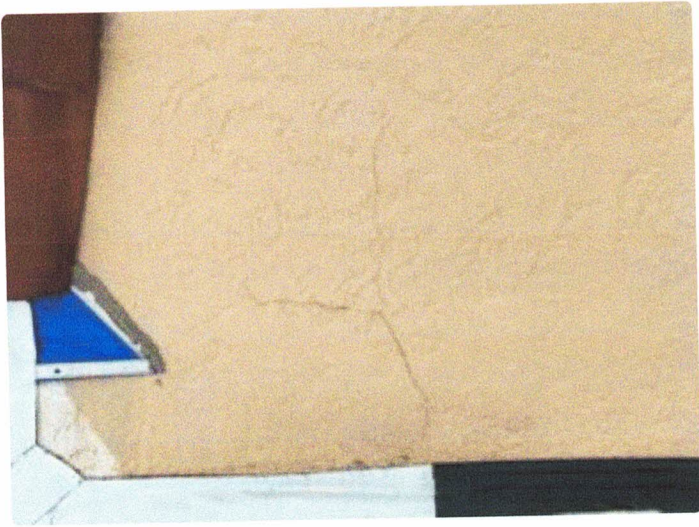
Crack on side of building on roof

| Maintenance | Crack in stucco on roof of building 9. Recommend routing and patching with mortar. |

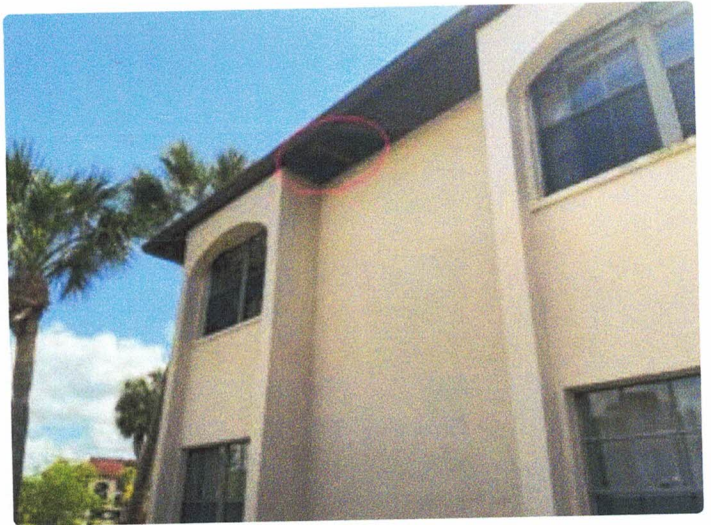
Missing soffit

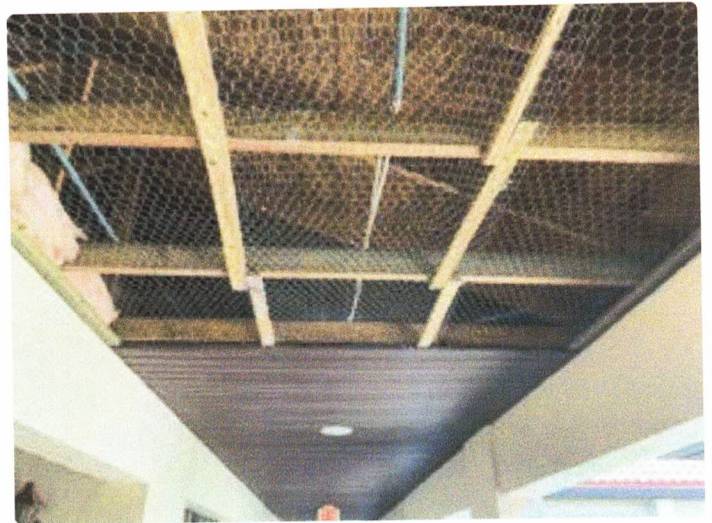
Missing soffit

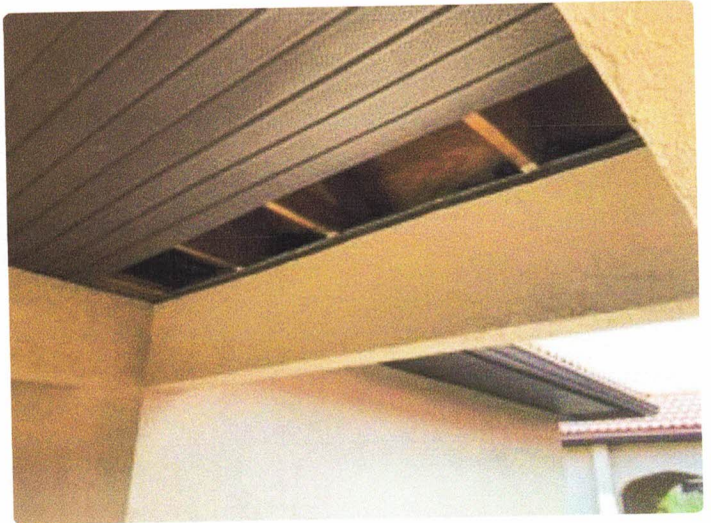
Missing soffit

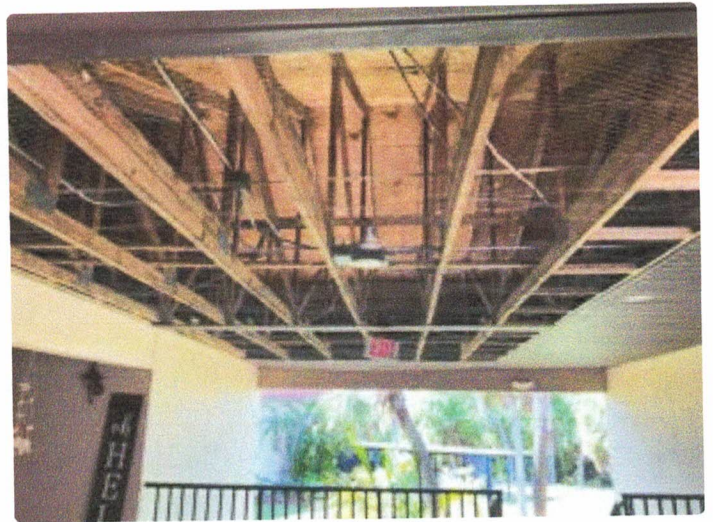
Missing soffit

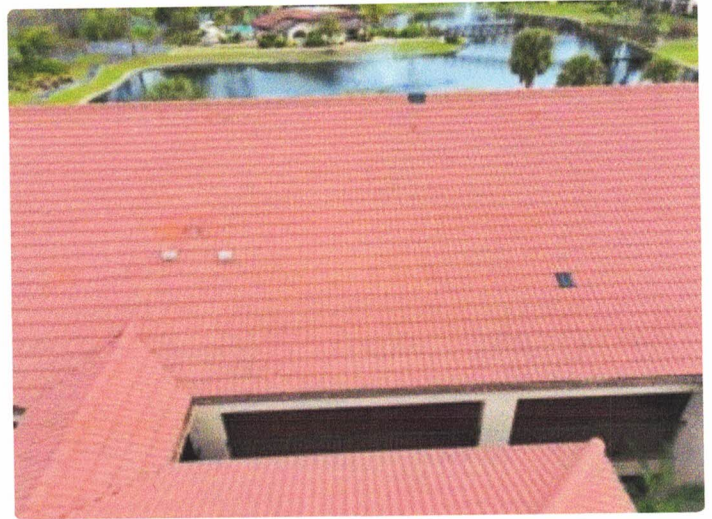
Broken barrel tiles
