## **Milestone Phase II Report**

**Roll's Landing Condominium Association, Inc.**

**23465 Harbor View Road**

1/30/2025

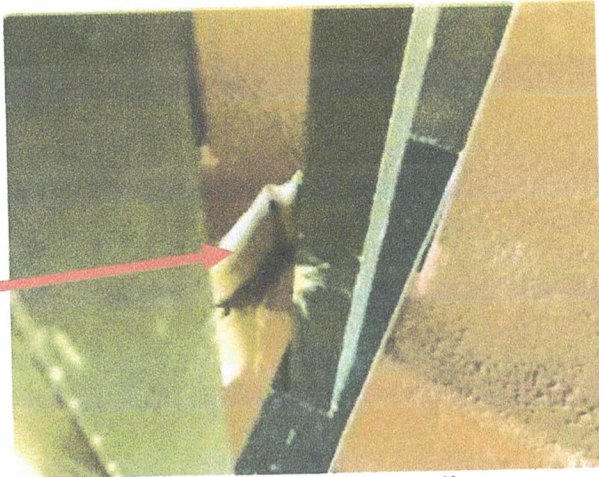
**Building 2**

Gap at top of stair landing

1. **Surface Refinishing:** Address gaps and imperfections by applying a high-quality non-shrink cementitious repair mortar to restore a smooth, uniform finish.
2. **No Structural Repairs Required:** As the rebars remain intact and no deep concrete deterioration was identified, no additional reinforcement or structural modifications are necessary at this time.

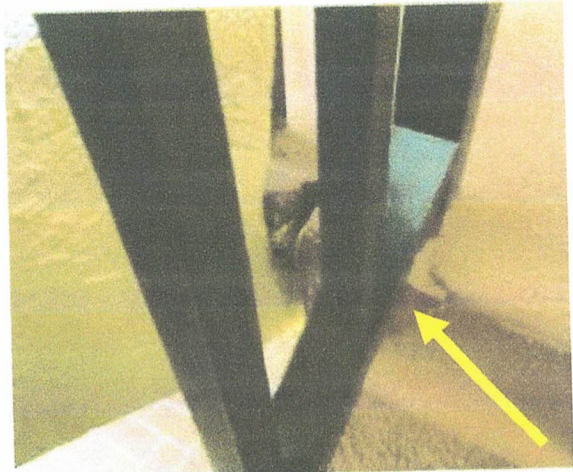
Spalling at top of stair landing

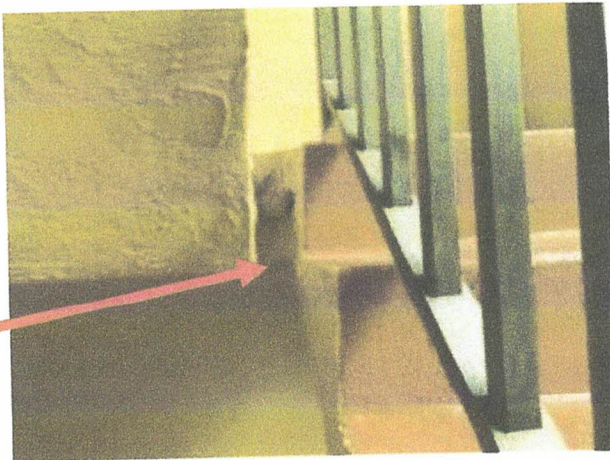
**Building 6**

Gap at top of stair landing

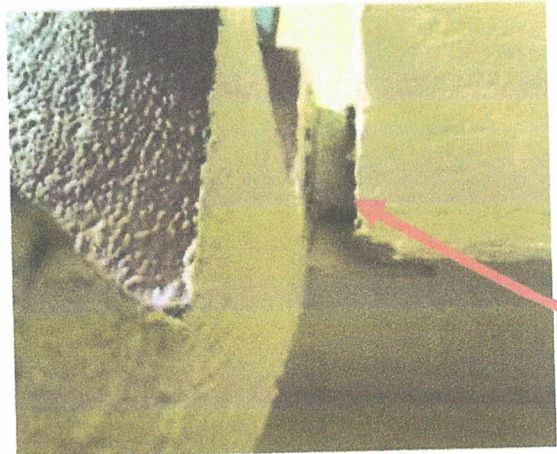
Gap at top of stair landing

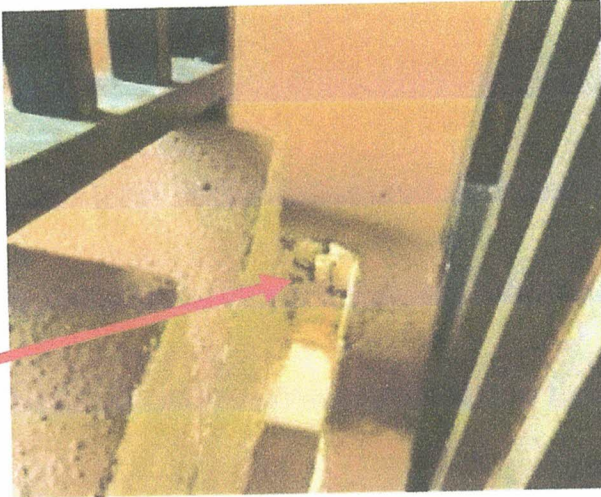
**Building 7**

Gap at top of stair landing

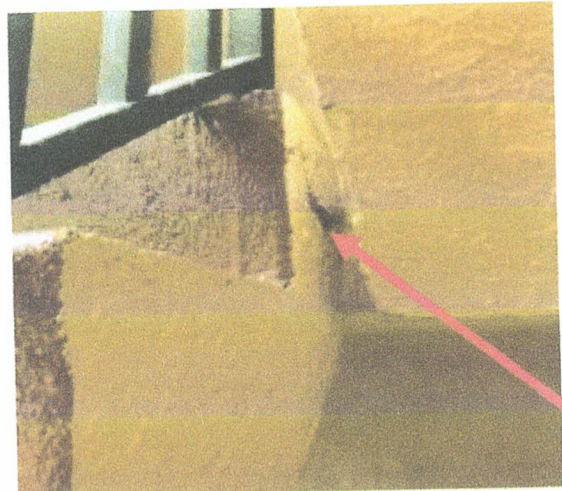
Gap at top of stair landing

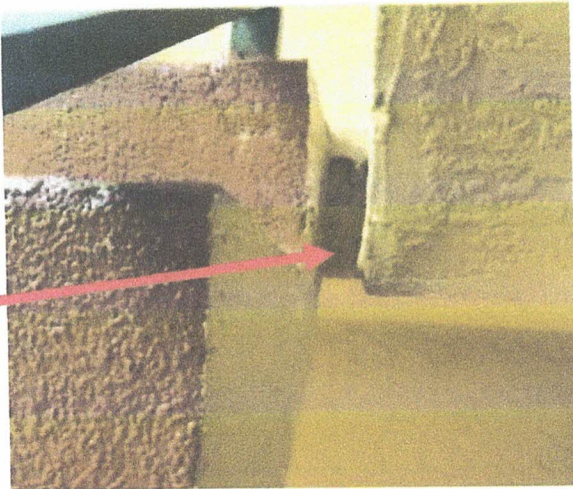
**Building 9**

Gap at top of stair landing

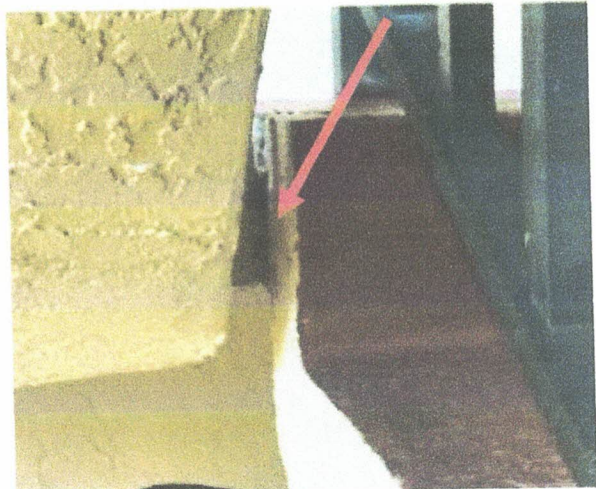
Gap at top of stair landing

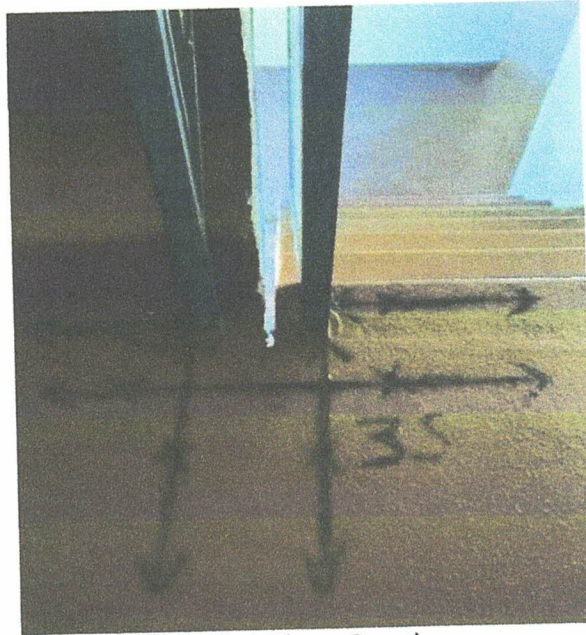
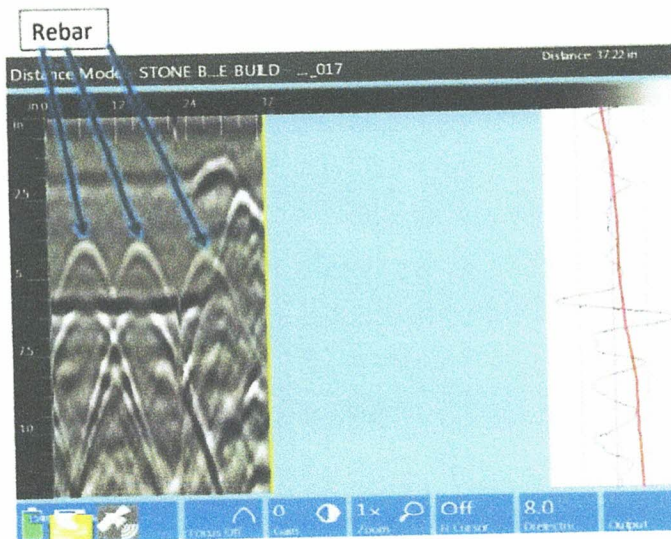
Third Floor South

The **GPR testing results confirmed that the embedded rebar in the stair landings remained intact**, and the structural integrity of the landings was **not compromised**. The defects observed were determined to be **cosmetic in nature** and did not indicate significant deterioration of the concrete.

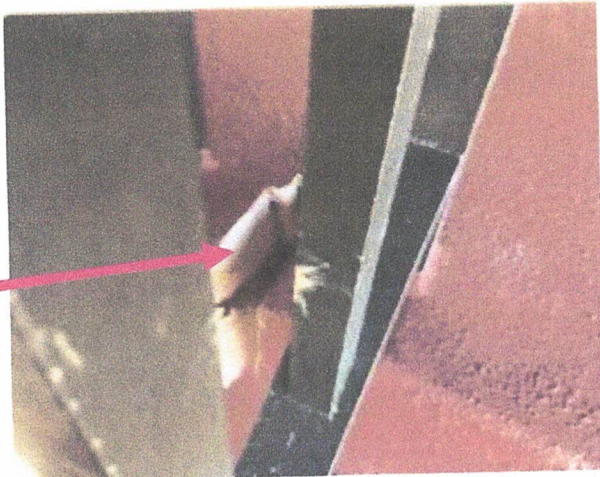
**Building 2**

Gap at top of stair landing

1. **Surface Refinishing:** Address gaps and imperfections by applying a high-quality non-shrink cementitious repair mortar to restore a smooth, uniform finish.
2. **No Structural Repairs Required:** As the rebars remain intact and no deep concrete deterioration was identified, no additional reinforcement or structural modifications are necessary at this time.

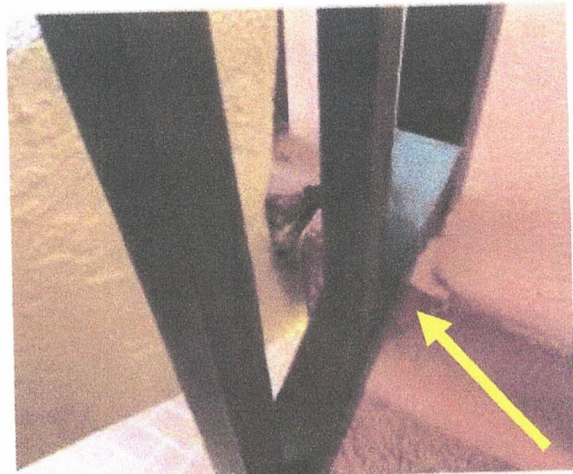
Spalling at top of stair landing

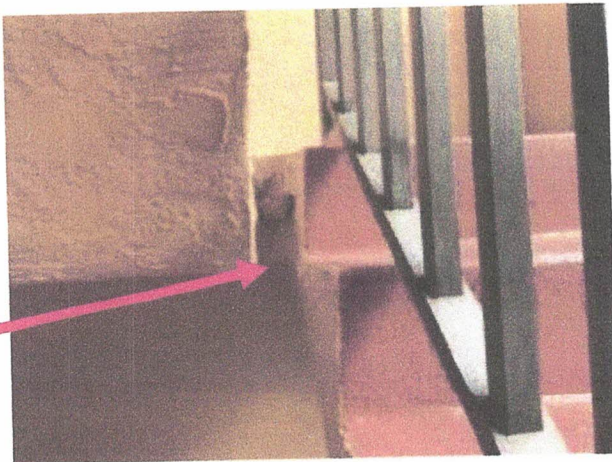
**Building 6**

Gap at top of stair landing

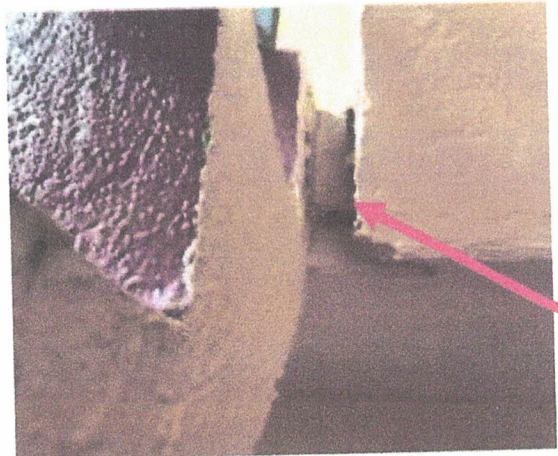
Gap at top of stair landing

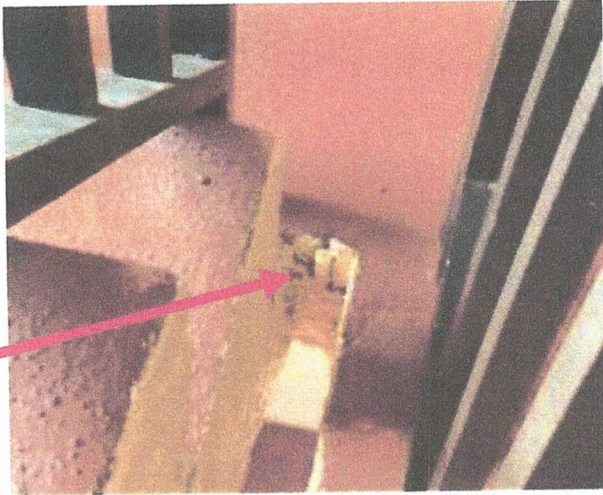
**Building 7**

Gap at top of stair landing

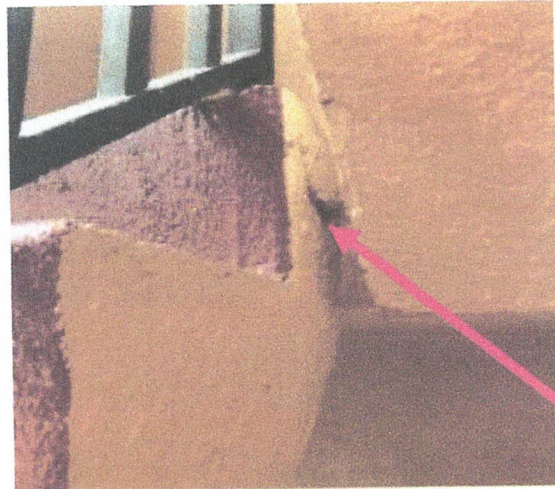
Gap at top of stair landing

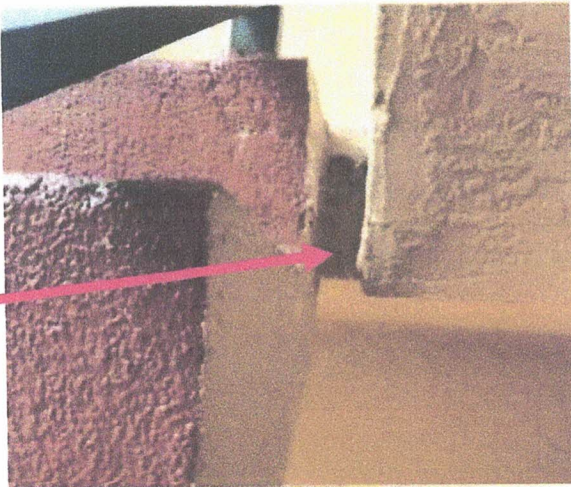
**Building 9**

Gap at top of stair landing

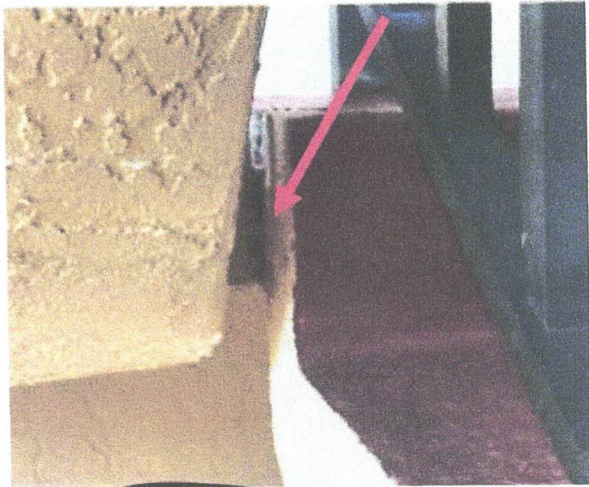
Gap at top of stair landing

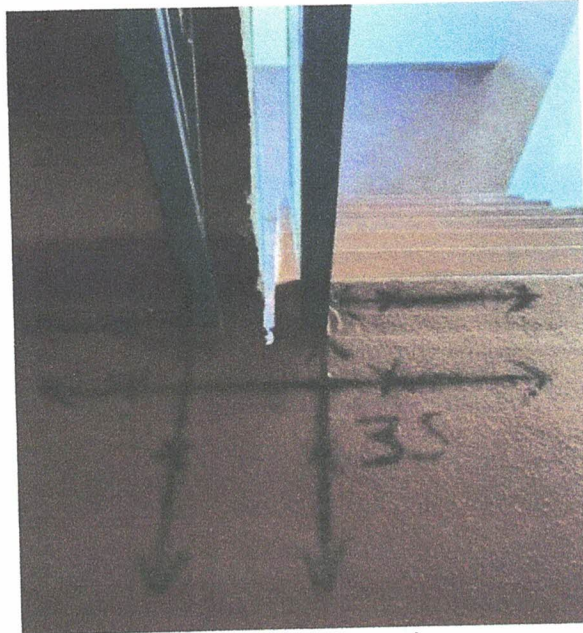
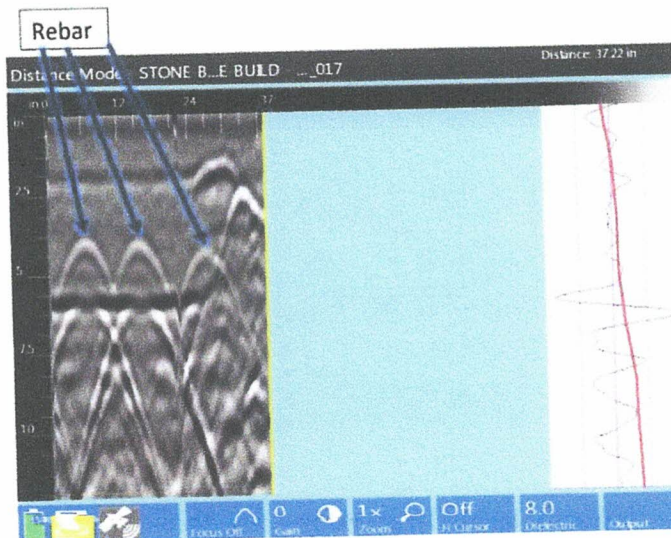
Third Floor South

The **GPR testing results confirmed that the embedded rebar in the stair landings remained intact**, and the structural integrity of the landings was **not compromised**. The defects observed were determined to be **cosmetic in nature** and did not indicate significant deterioration of the concrete.
