**Milestone Phase I Report**  
**Roll's Landing Condominium Association, Inc.**

Report Date: 7/12/2024

Inspection Date: 3/21/2024

Per your request, a team from Stone Inspections Group, LLC (SIG) conducted a Phase I Milestone Inspection of the referenced property on the following buildings:

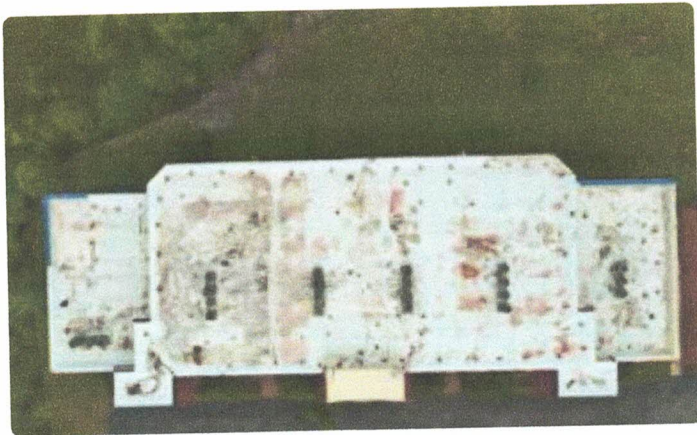
Typical remediation overview

Broken barrel tiles and remedial solutions observed. Recommend replacing all broken tiles and repairing temporary remediation failure. Flat roofs were tarped up for remediation in plans to replace. Recommend replacing the flat roof. Soffit missing throughout property. Recommend replacing all missing soffit

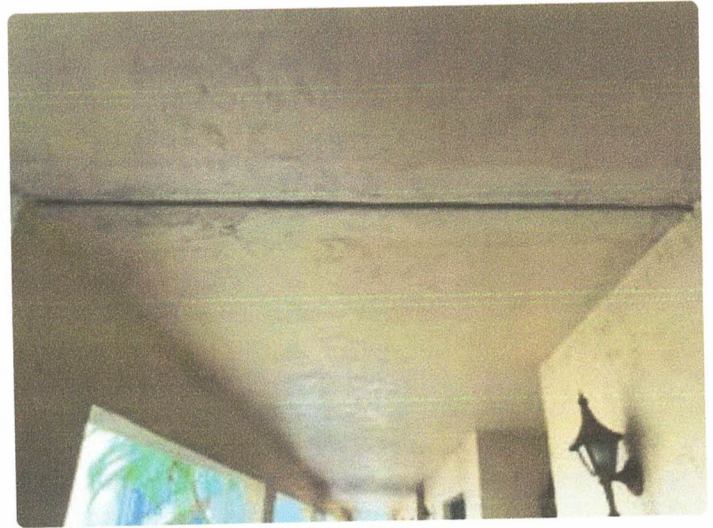
| Maintenance | Gap in control joint under walkway of building 10. Recommend putting a backer rod in place and filling with sealant. Minor cracking at the edge of the bottom of the walkway was observed in building 10. Recommend routing and patching with mortar. |

Gap in control joint under veranda walkway

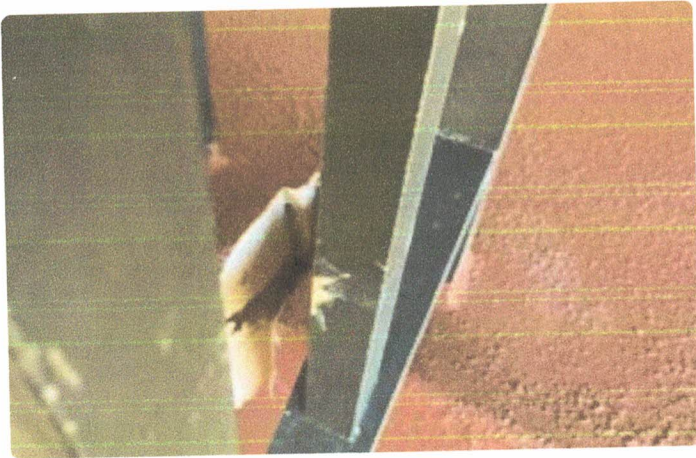
Spalling on face of landing

| Deficiencies | Spalling was also observed at the insides of several landings. Recommend hiring a contractor to perform ultrasonic pulse velocity testing of all landings on and between floors on buildings 2, 6, 7, and 9. Testing will determine the extent of the spalling and will indicate if it can be patched with mortar or if parts of the landings need to be replaced. |

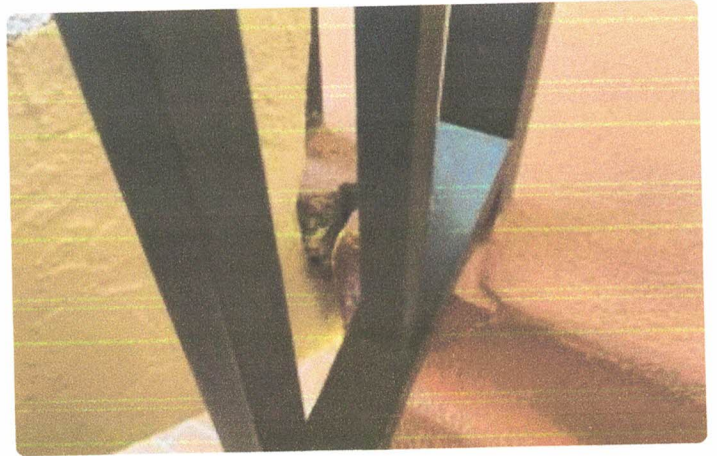
Spalling on landing

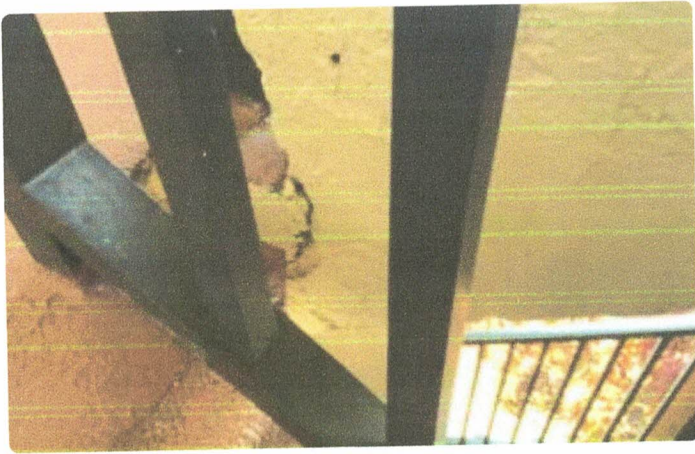
Spalling on landing

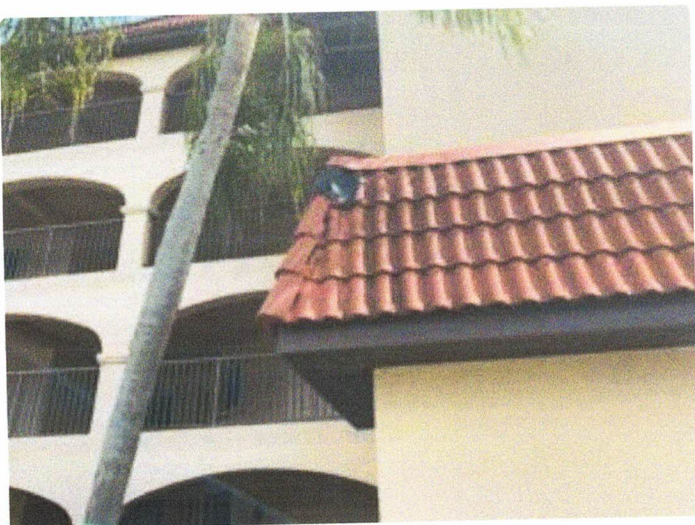
Remedial fix on broken barrel tile

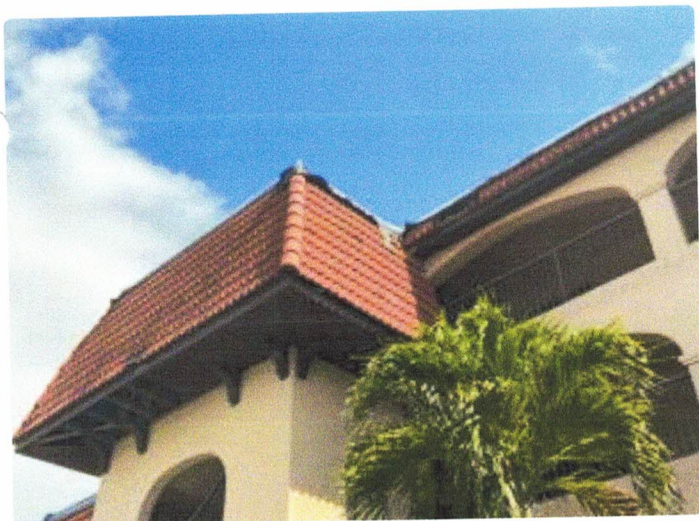
Remedial fix on broken barrel tiles

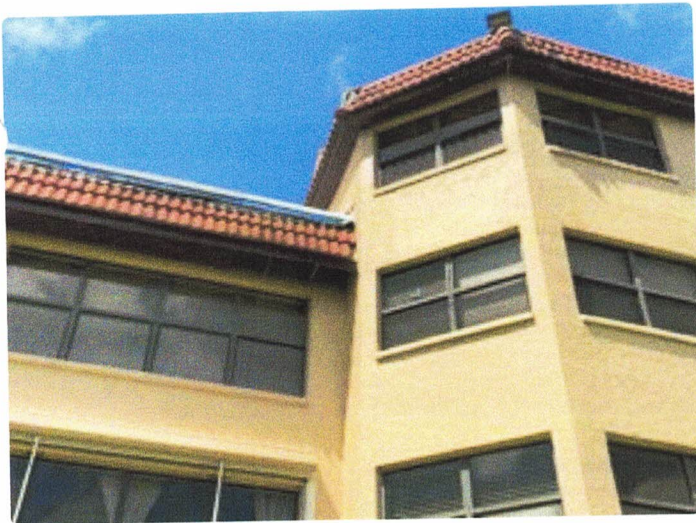
Broken barrel tiles

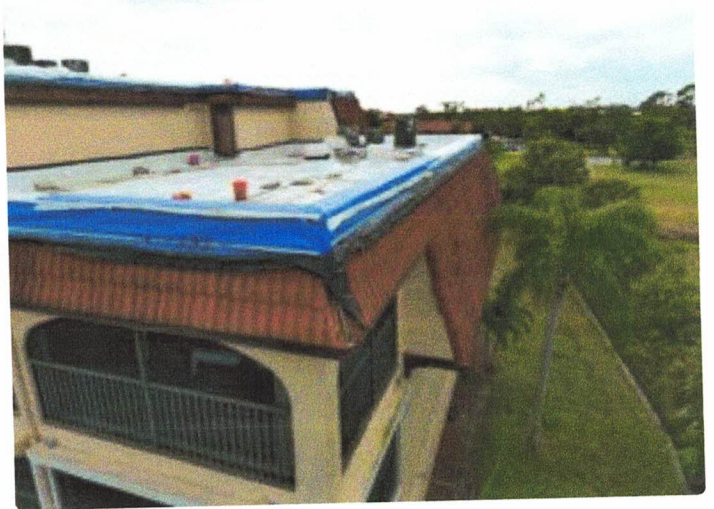
Broken barrel tiles

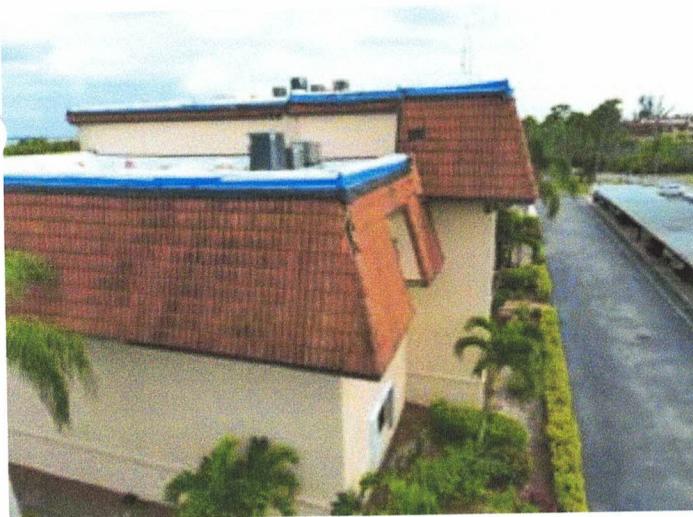
Broken barrel tiles

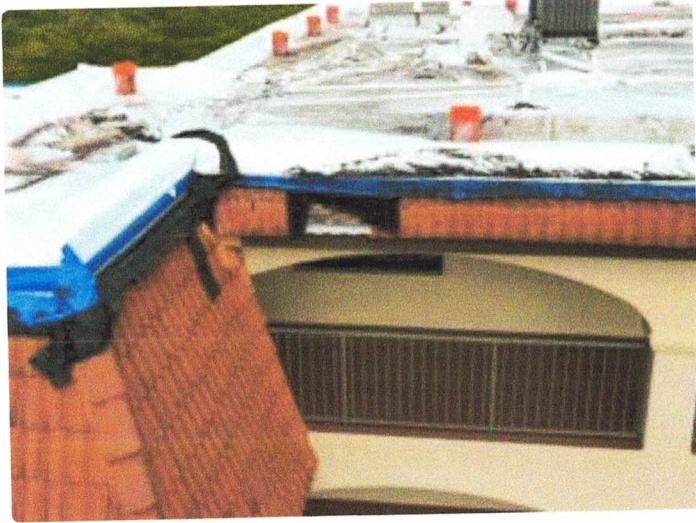
Temporary remediation failure

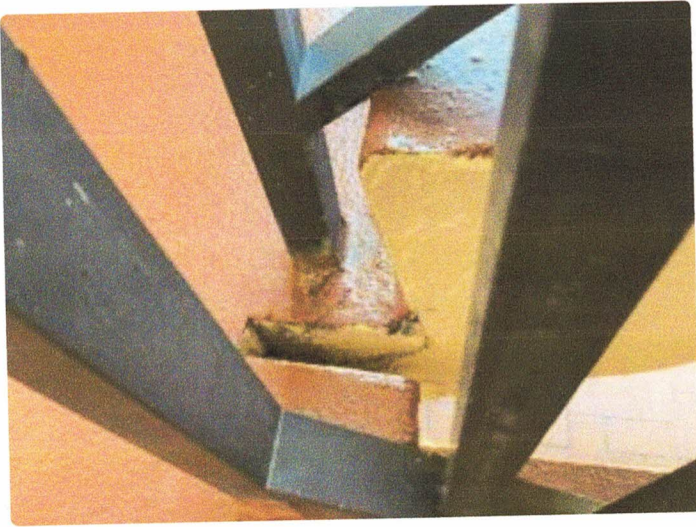
Building 2

Spalling on inside of stairwell

Spalling was also observed at the insides of several landings. Recommend hiring a contractor to perform ultrasonic pulse velocity testing of all landings on and between floors on buildings 2, 6, 7, and 9. Testing will determine the extent of the spalling and will indicate if it can be patched with mortar or if parts of the landings need to be replaced.

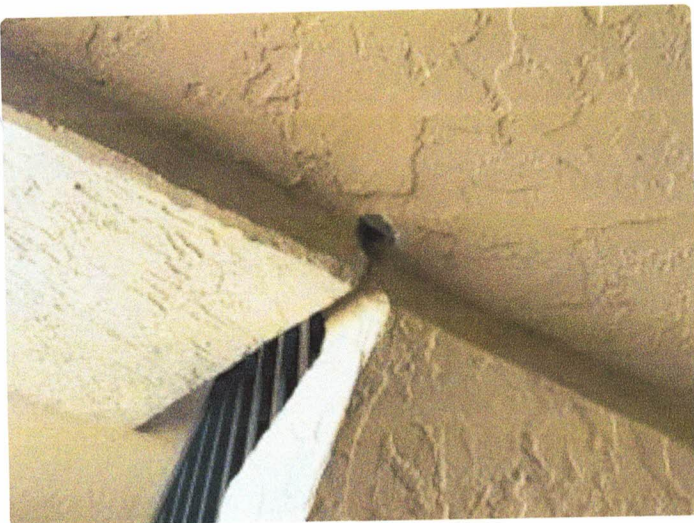
Crack under stairwell

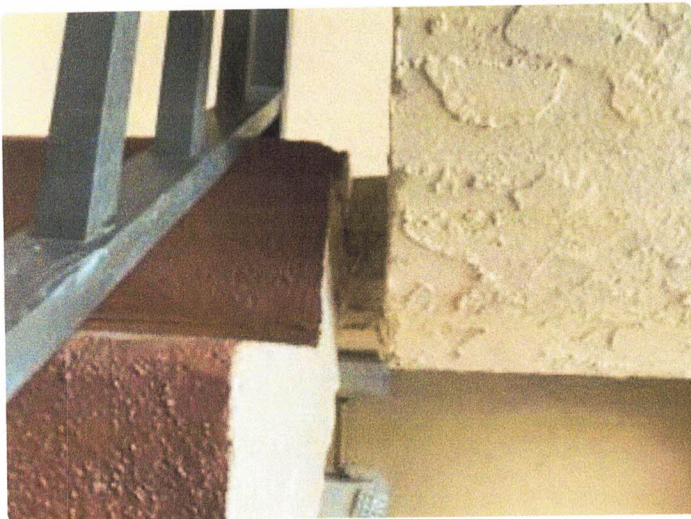
Spalling on right stairwell landing

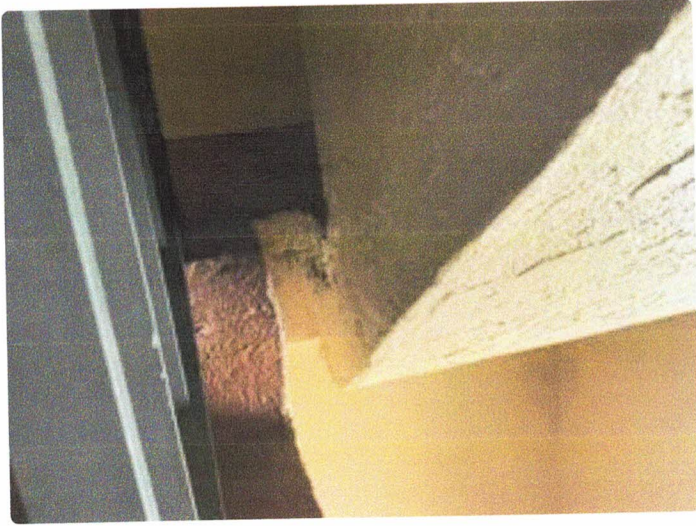
Building 6

Spalling on right stairwell landing

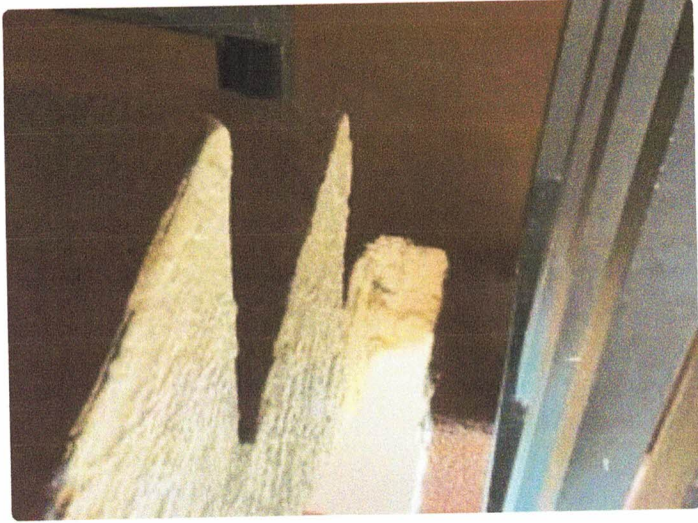
Building 7

Spalling on left stairwell landing

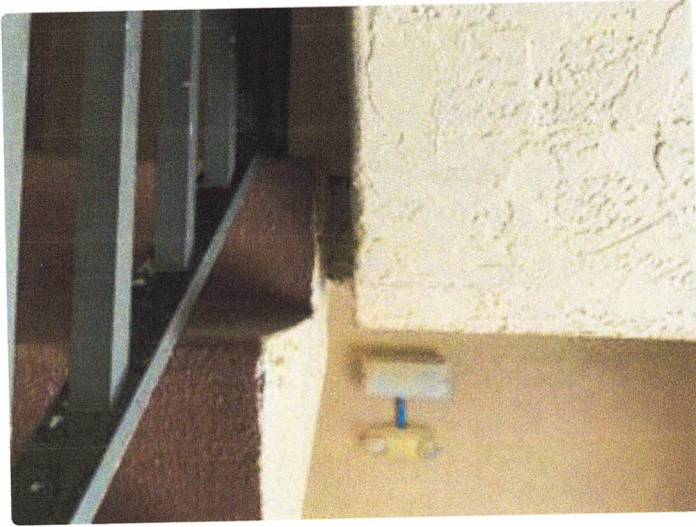
Building 7

Spalling on right stairwell landing

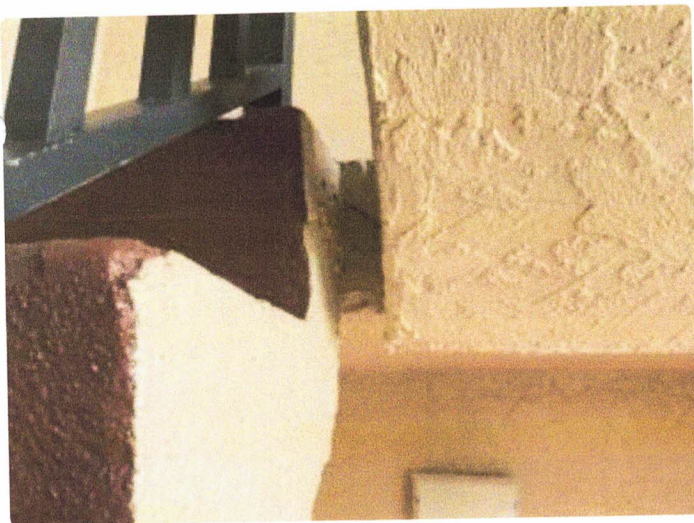
Spalling on right stairwell landing

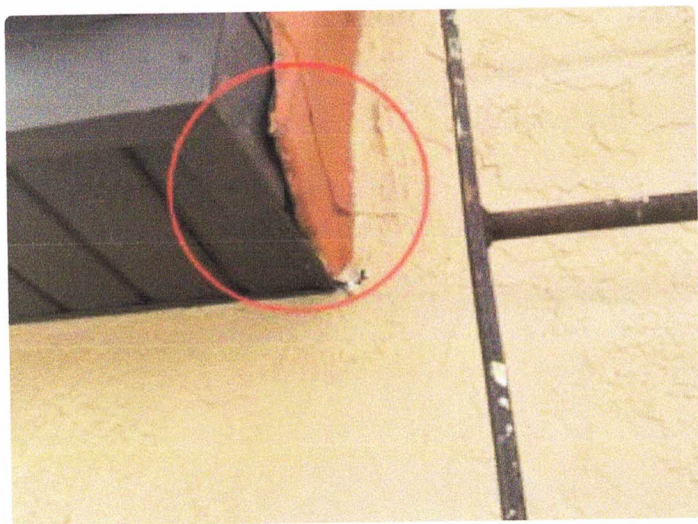
Building 8

Gap at flashing

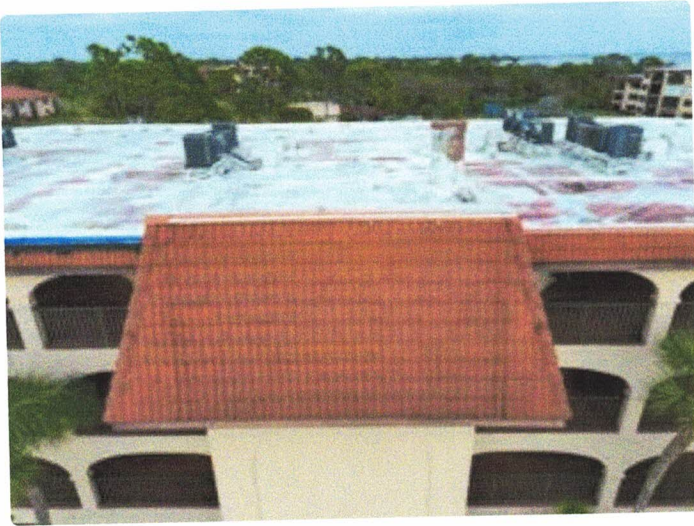
Building 8

Broken barrel tiles

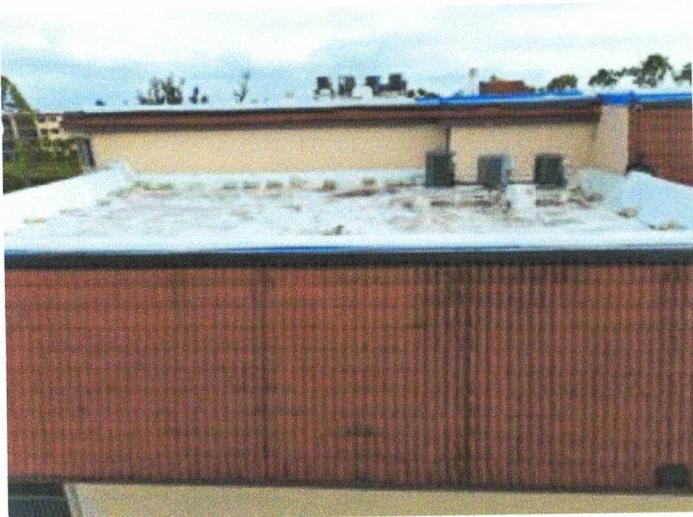
Broken barrel tiles

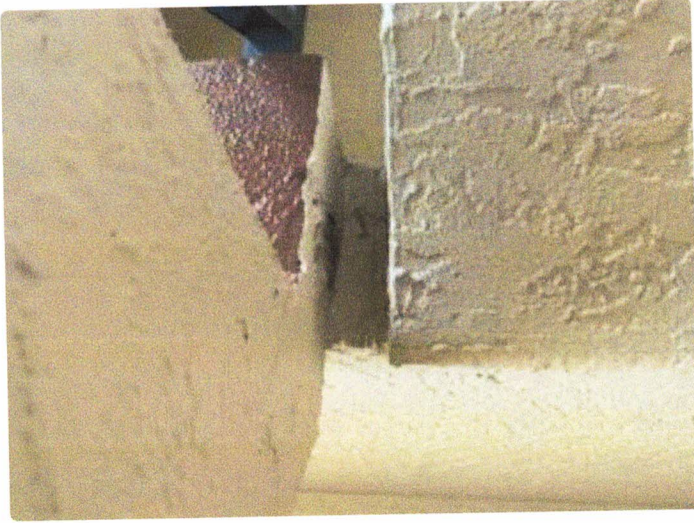
Building 9

Spalling on right stairwell landing

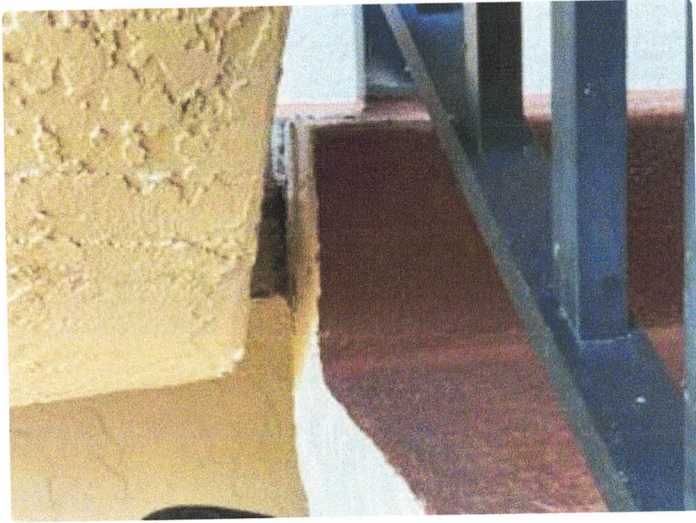
Building 9

Spalling on left stairwell landing

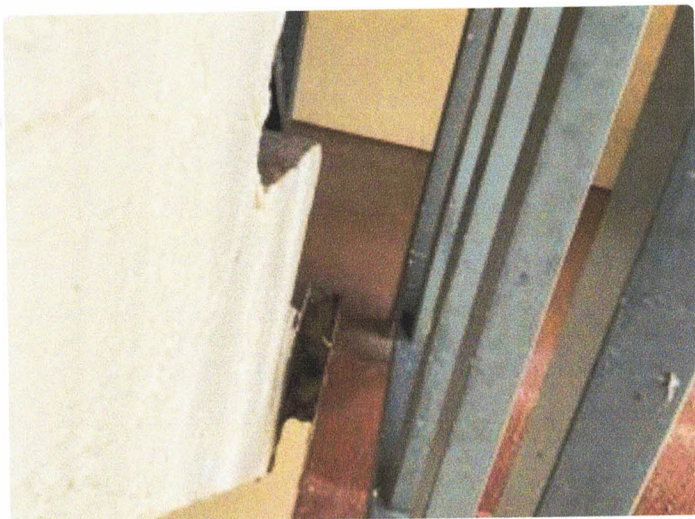
Spalling on left stairwell landing

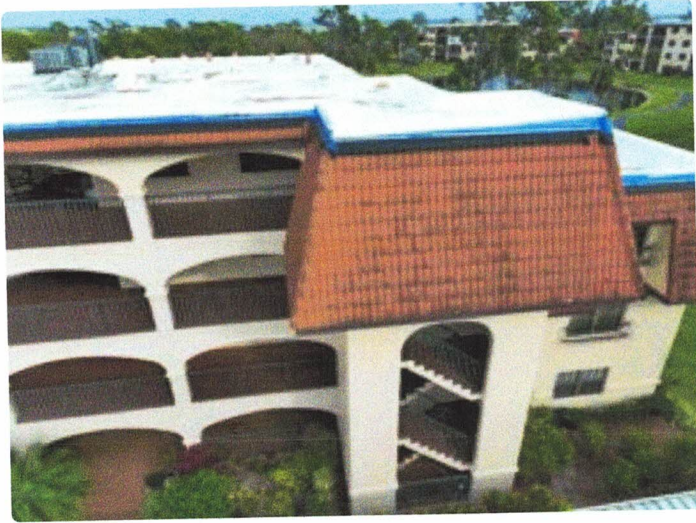
Broken barrel tile

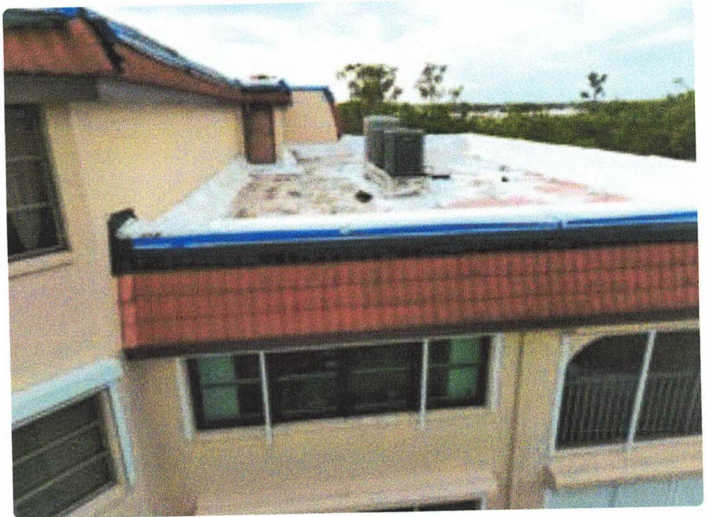
Gap at tiles

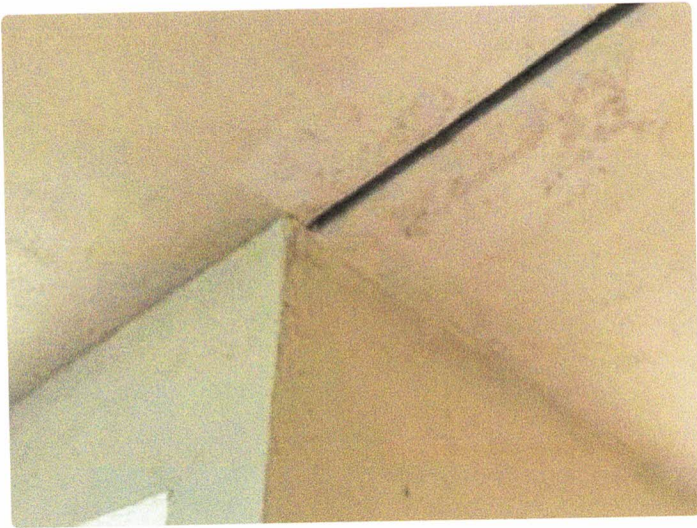
Gap in control joint under walkway

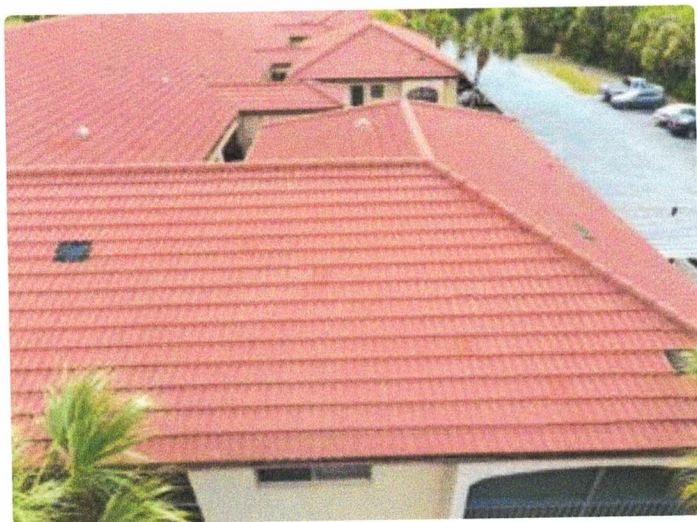
Broken barrel tiles

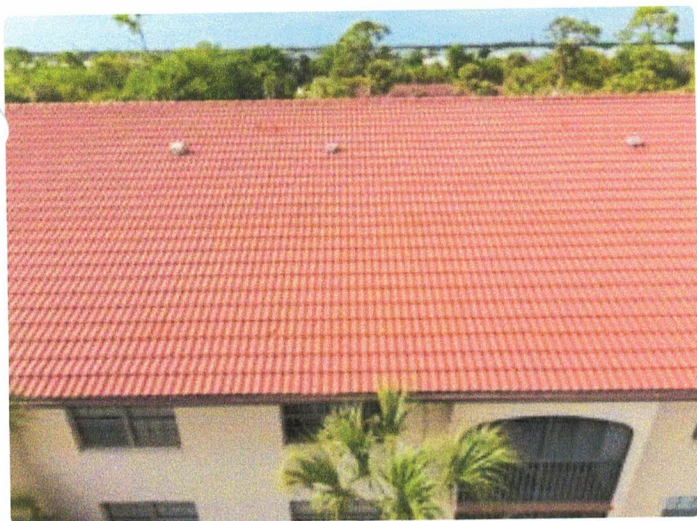
Broken barrel tiles

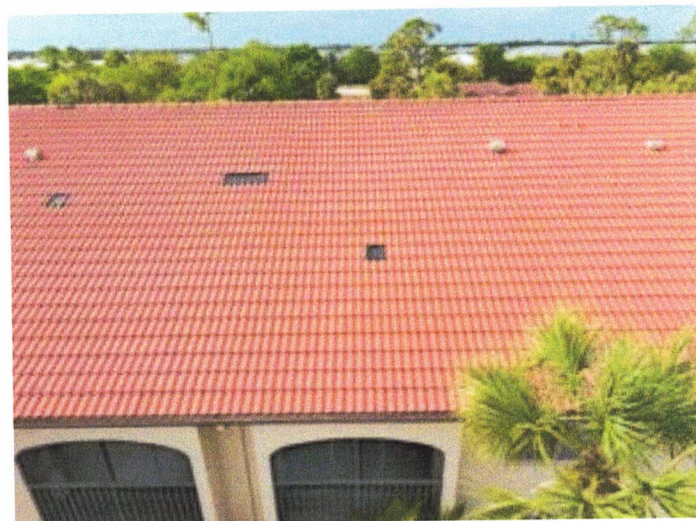
Broken barrel tiles

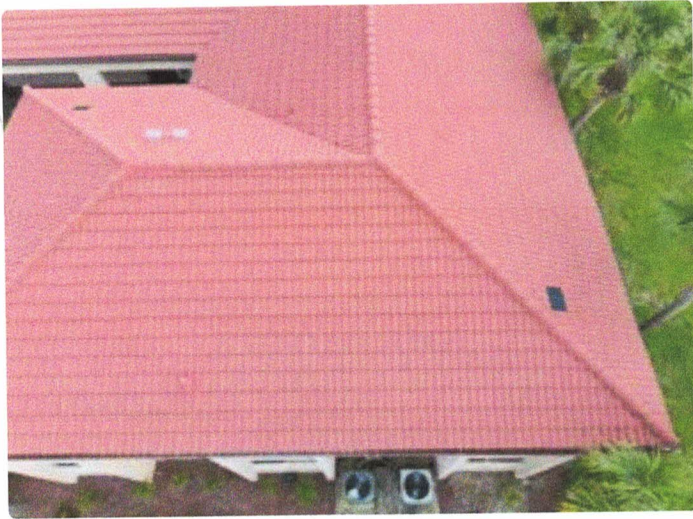
Slipped barrel tiles

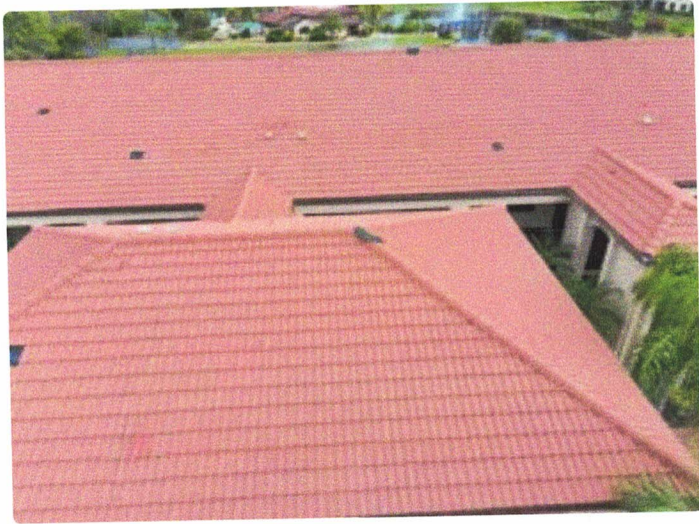
Broken barrel tiles
