**Milestone Phase I Report**  
**Roll's Landing Condominium Association, Inc.**

Report Date: 7/12/2024

Inspection Date: 3/21/2024

Per your request, a team from Stone Inspections Group, LLC (SIG) conducted a Phase I Milestone Inspection of the referenced property on the following buildings:

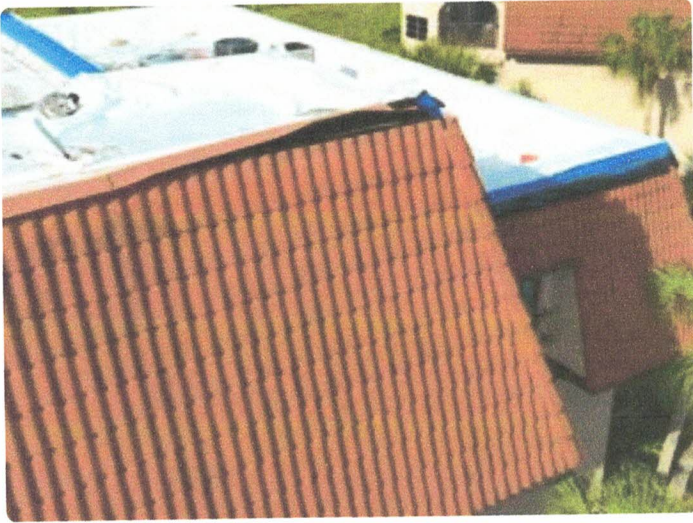
Twisted ridge cap

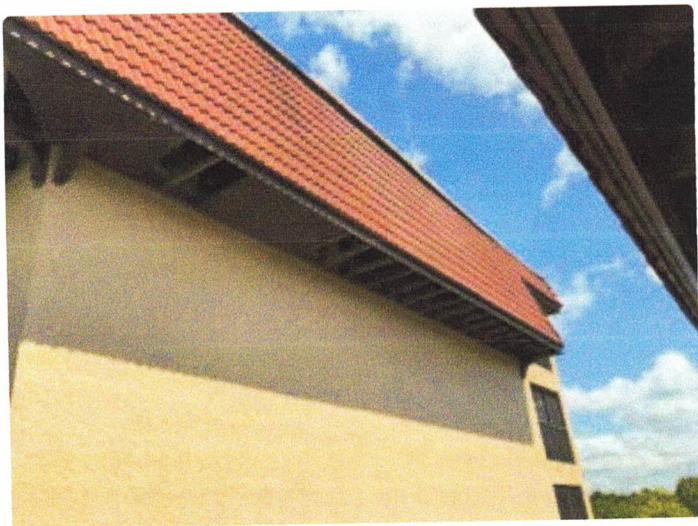
Missing soffit

Broken barrel tiles and remedial solutions observed. Recommend replacing all broken tiles and repairing temporary remediation failure. Flat roofs were tarped up for remediation in plans to replace. Recommend replacing the flat roof. Soffit missing throughout property. Recommend replacing all missing soffit

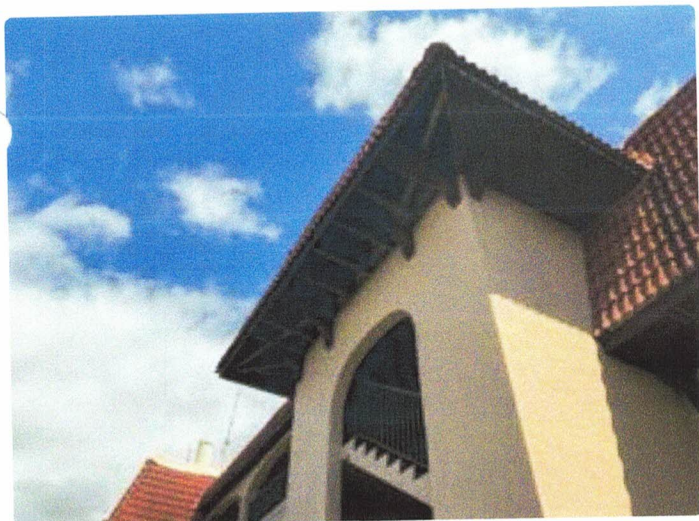
Missing soffit

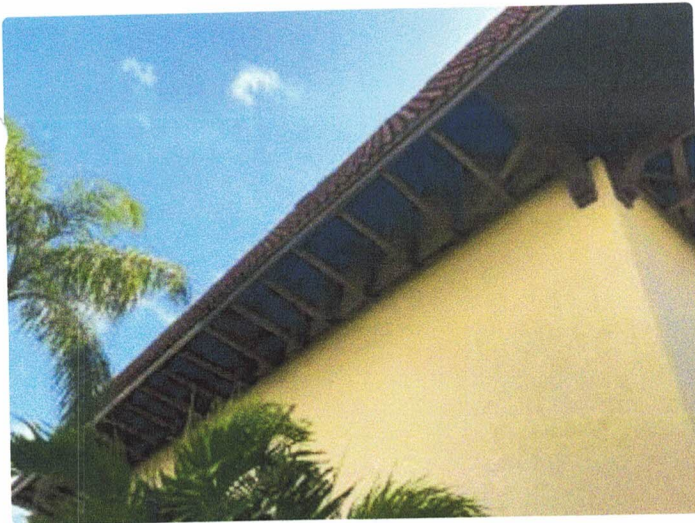
Missing soffit

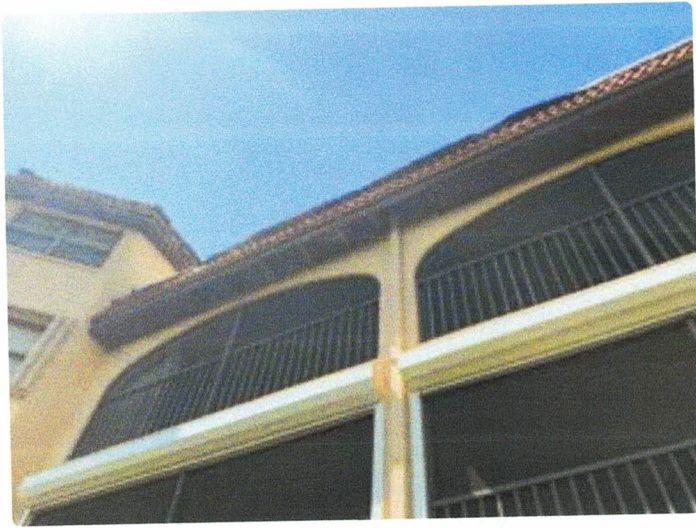
Missing soffit

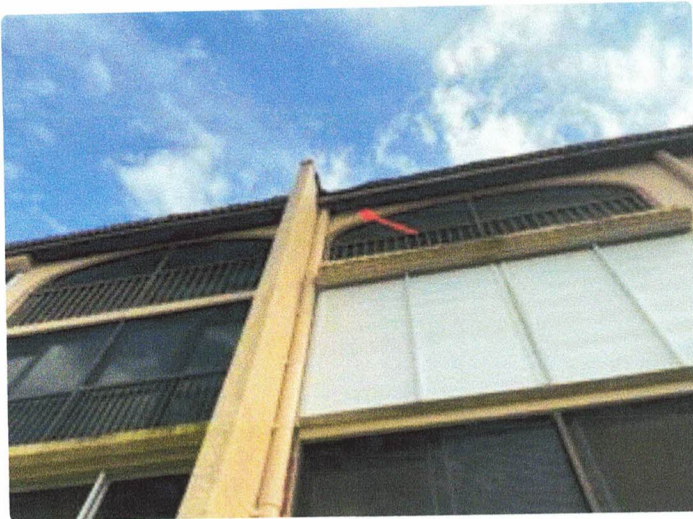
Missing soffit

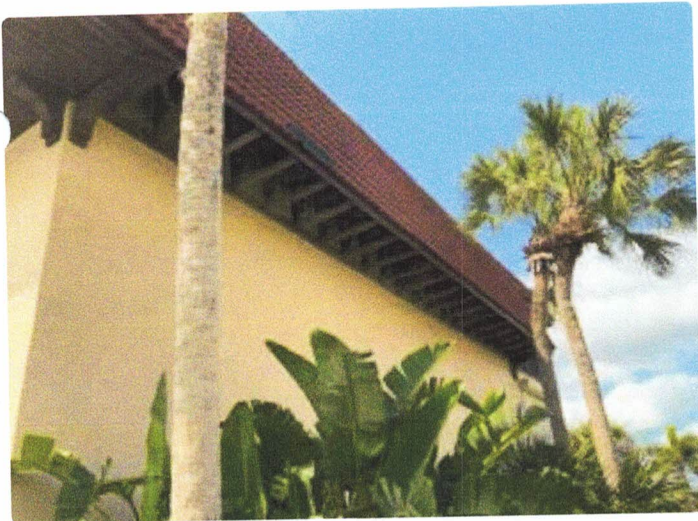
Missing soffit

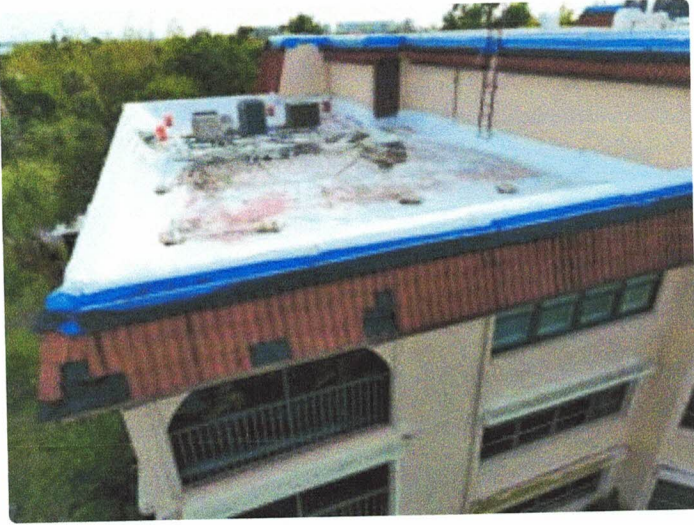
Building 7

Barrel tile remediation

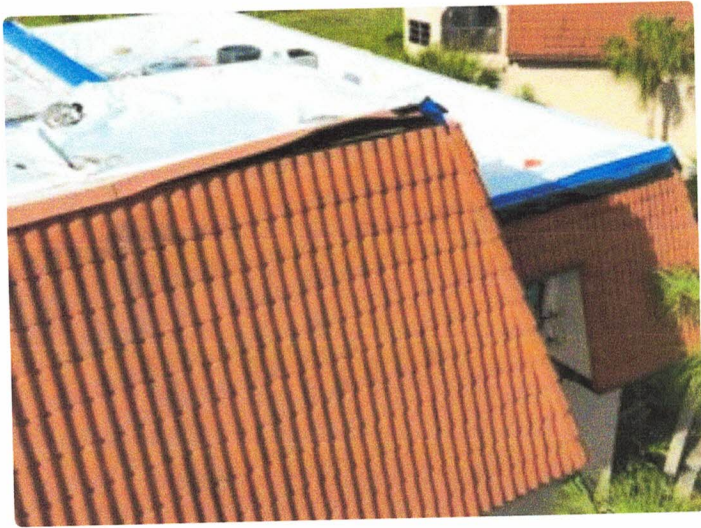
Building 7

Rotated ridge cap

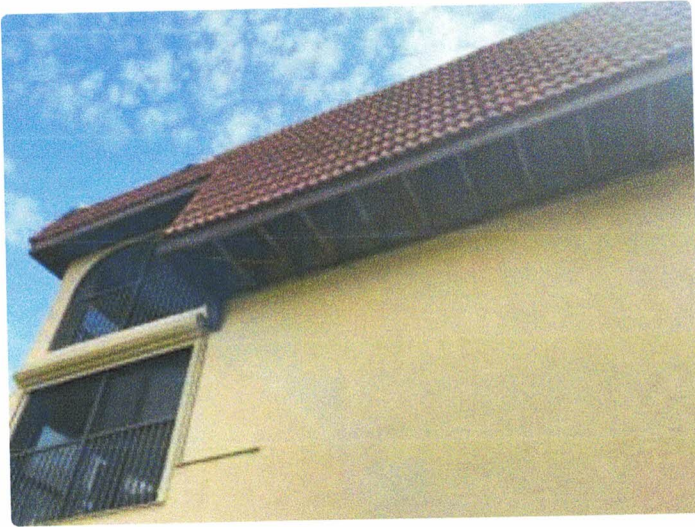
Building 8

Missing soffit

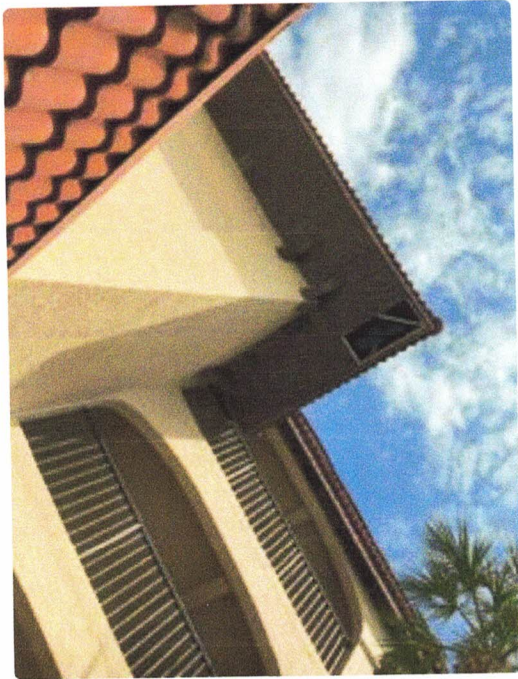
Building 8

Missing soffit

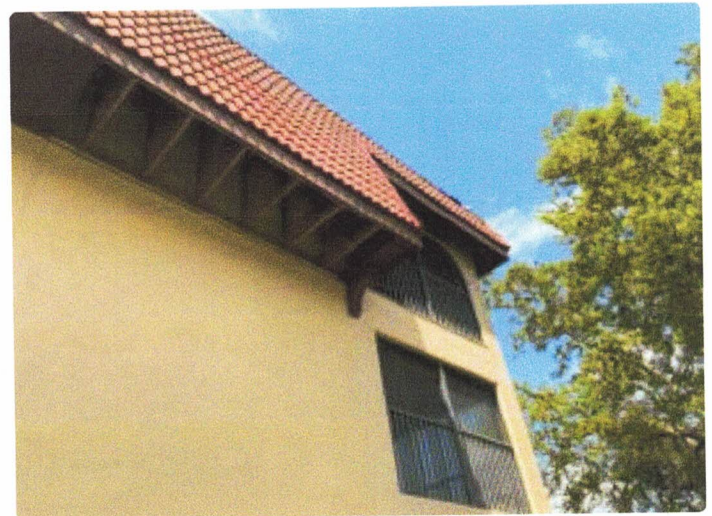
Missing soffit

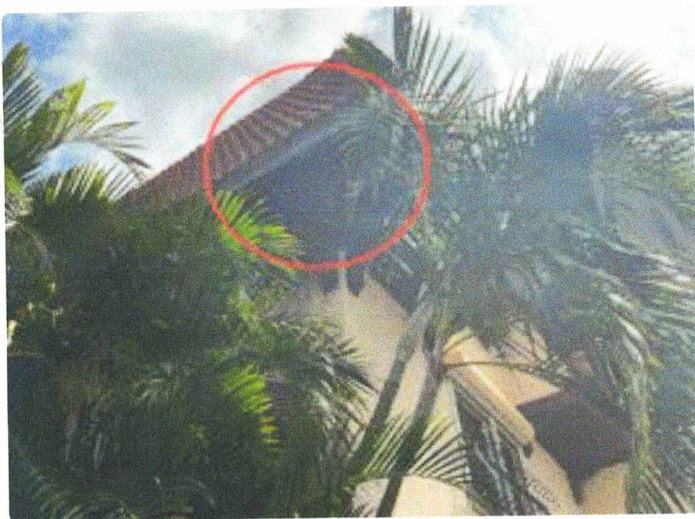
Missing soffit

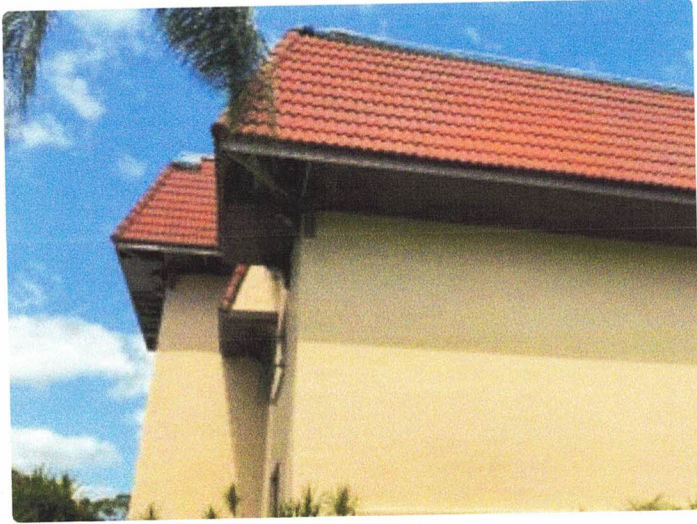
Missing soffit

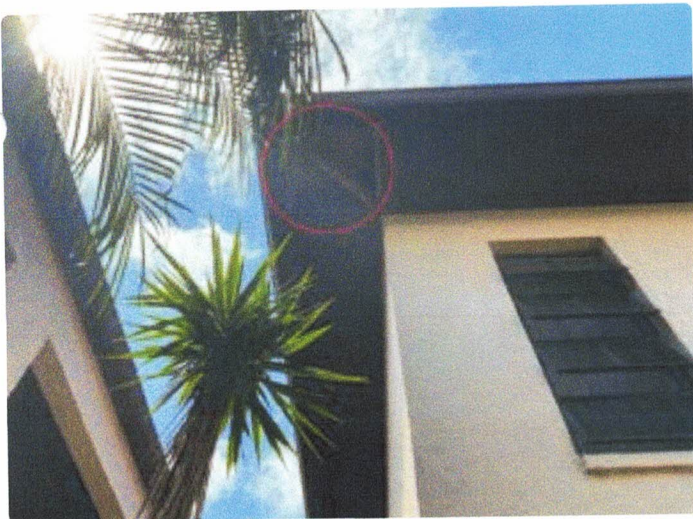
Missing soffit

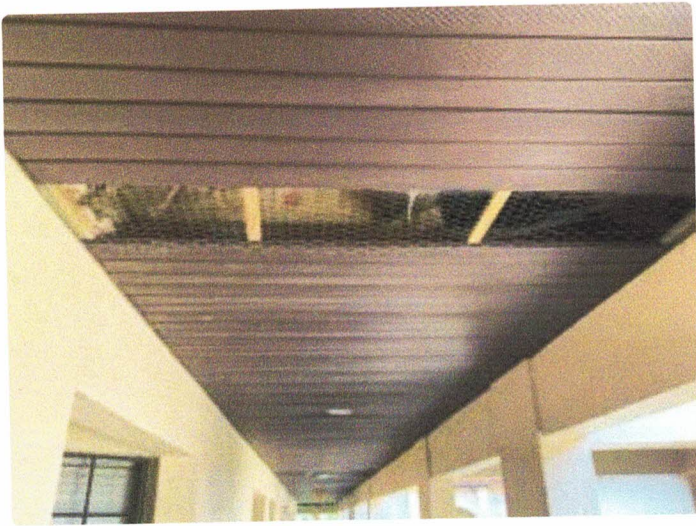
Missing soffit

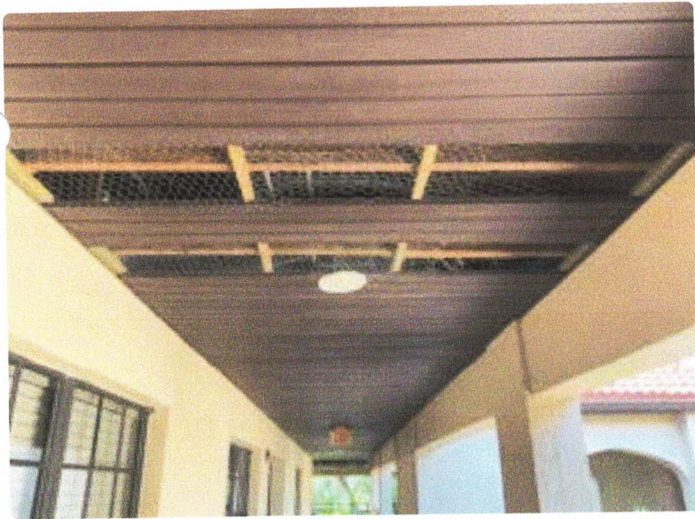
Missing soffit
